Watershed Emergency Response Team Evaluation BOND FIRE

CA-ORC-136890

January 8, 2021

BOND FIRE – WERT ASSESMENT EXECUTIVE SUMMARY

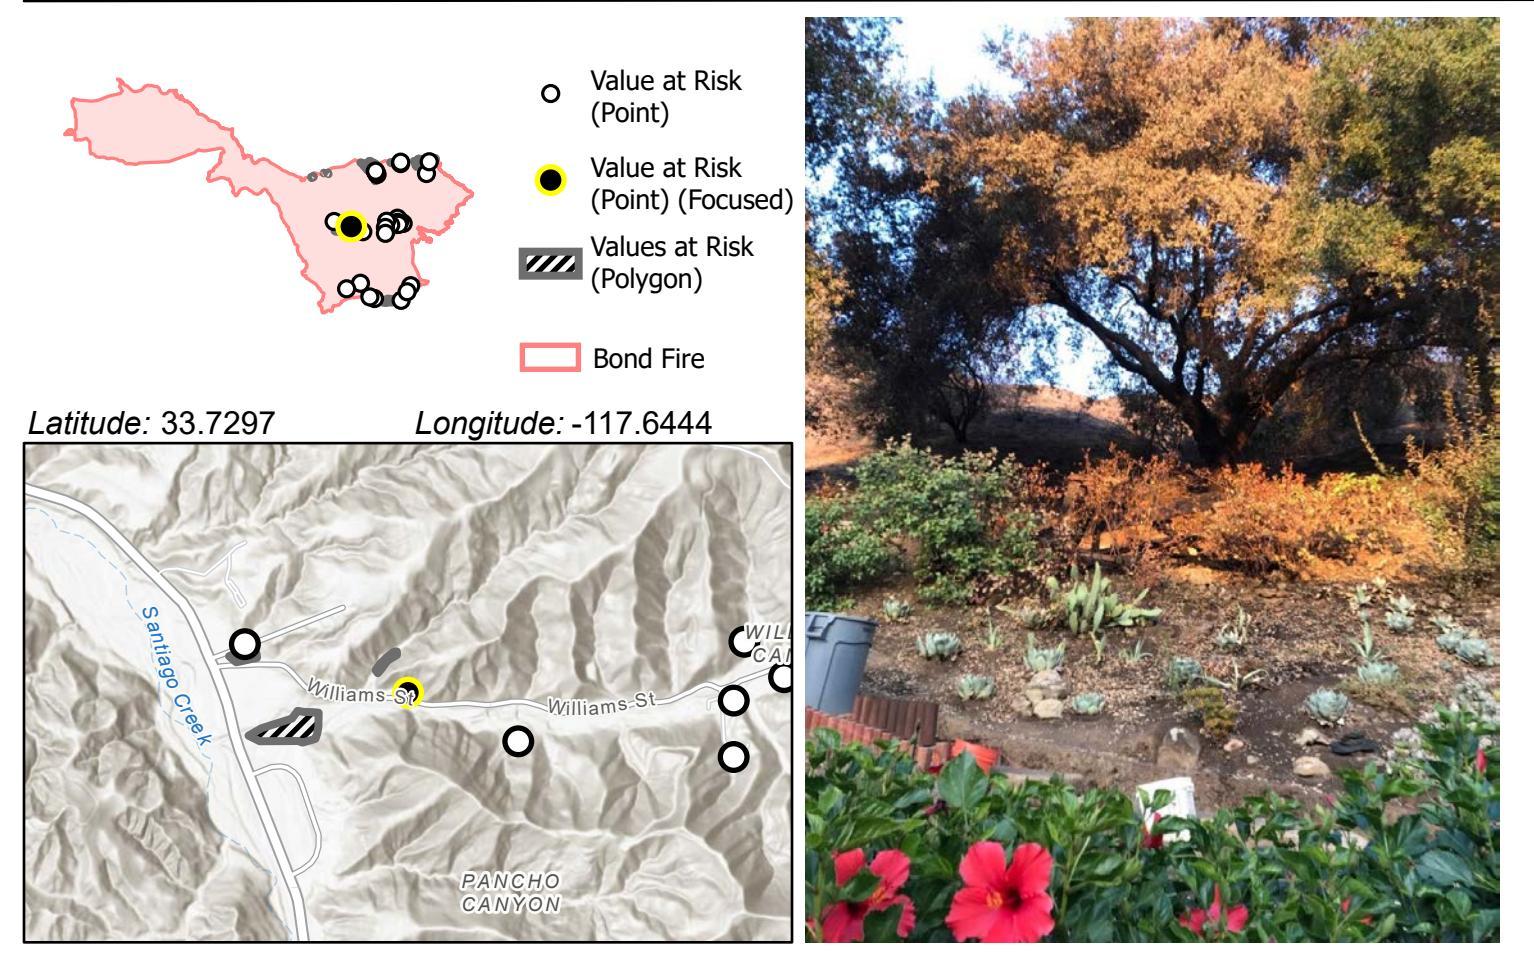
Description: Existing deflection structures need to be rebuilt from last fire in 2014.

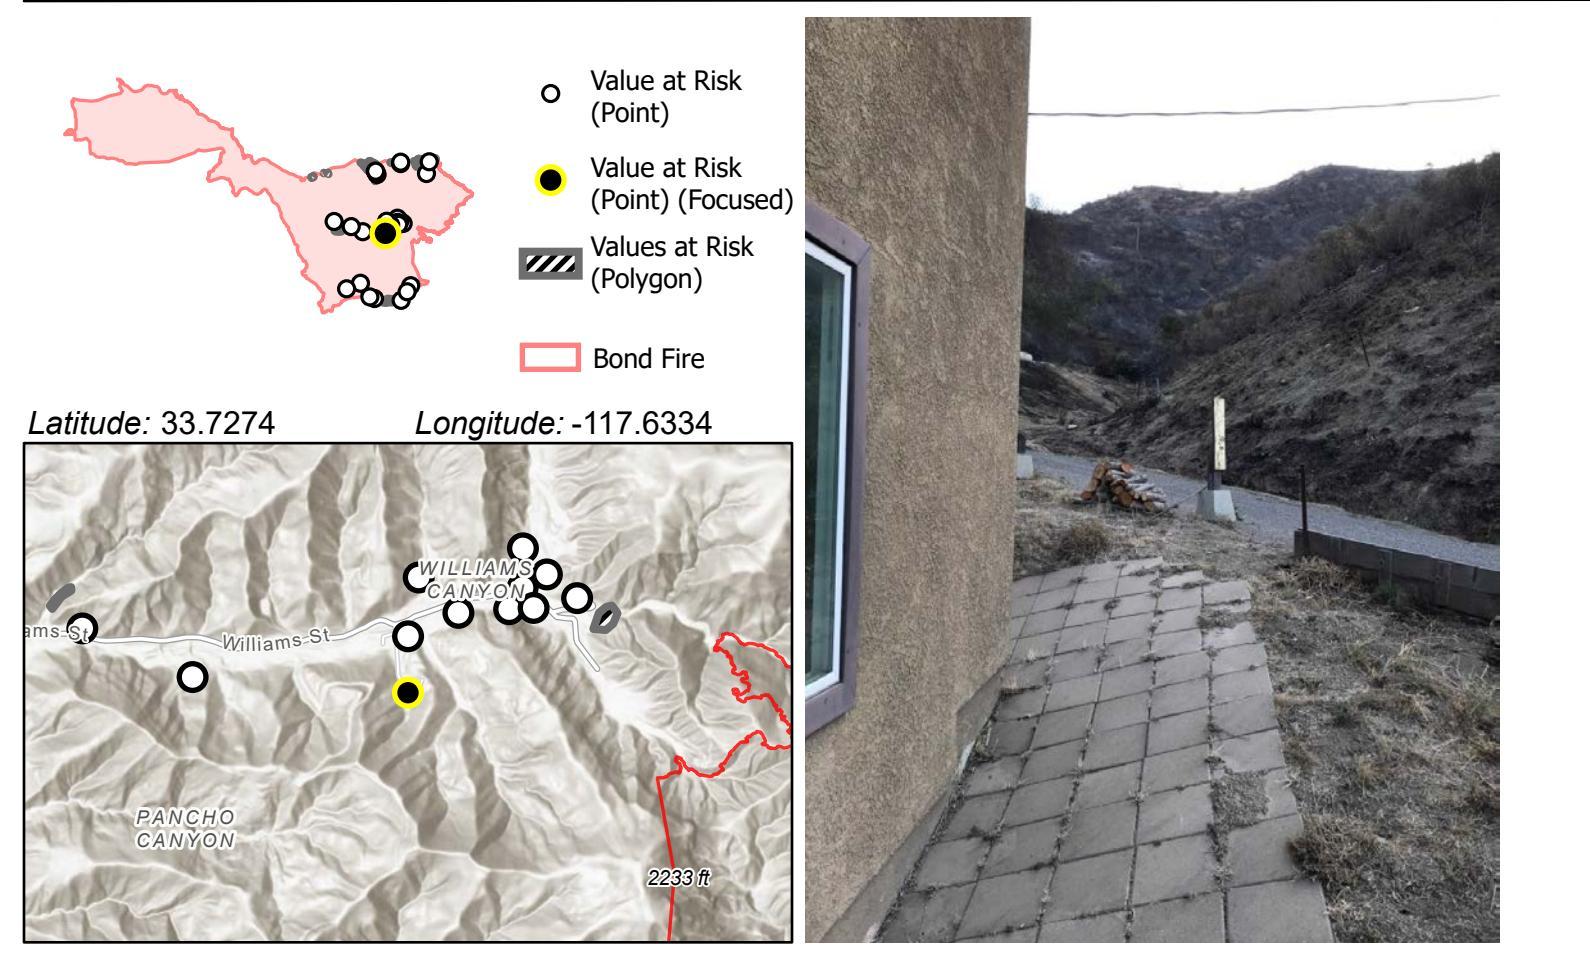
Description: Consider evacuating in predicted heavy rains. Rockfall hazards as well

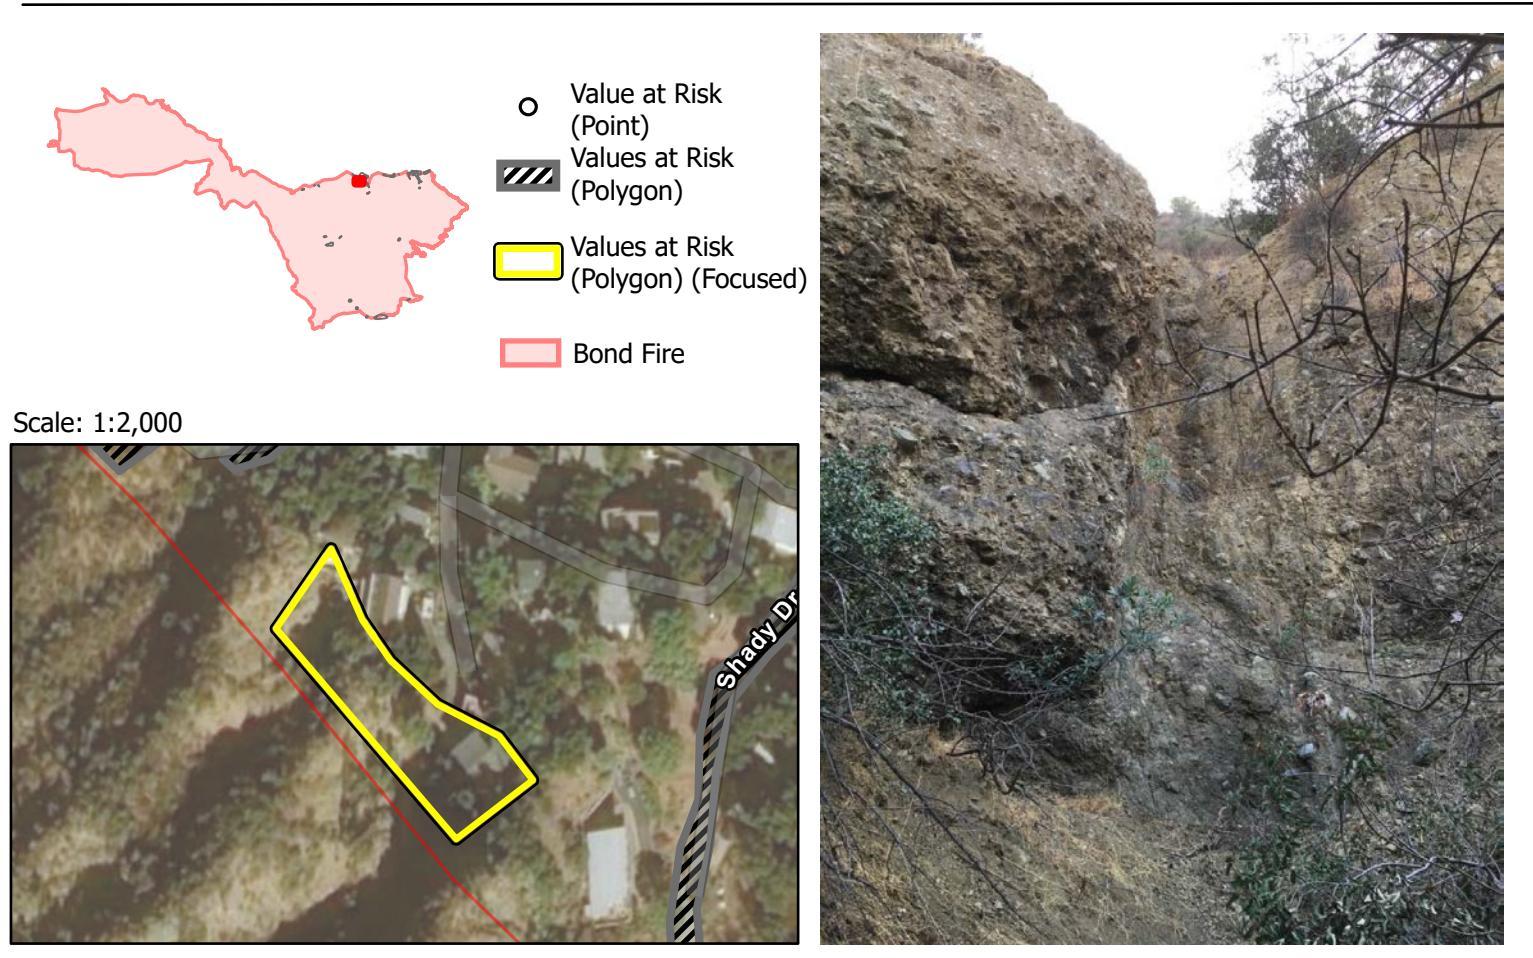
Description: Consider Evacuation. There is a home sited in the active stream channel at high risk for inundation.

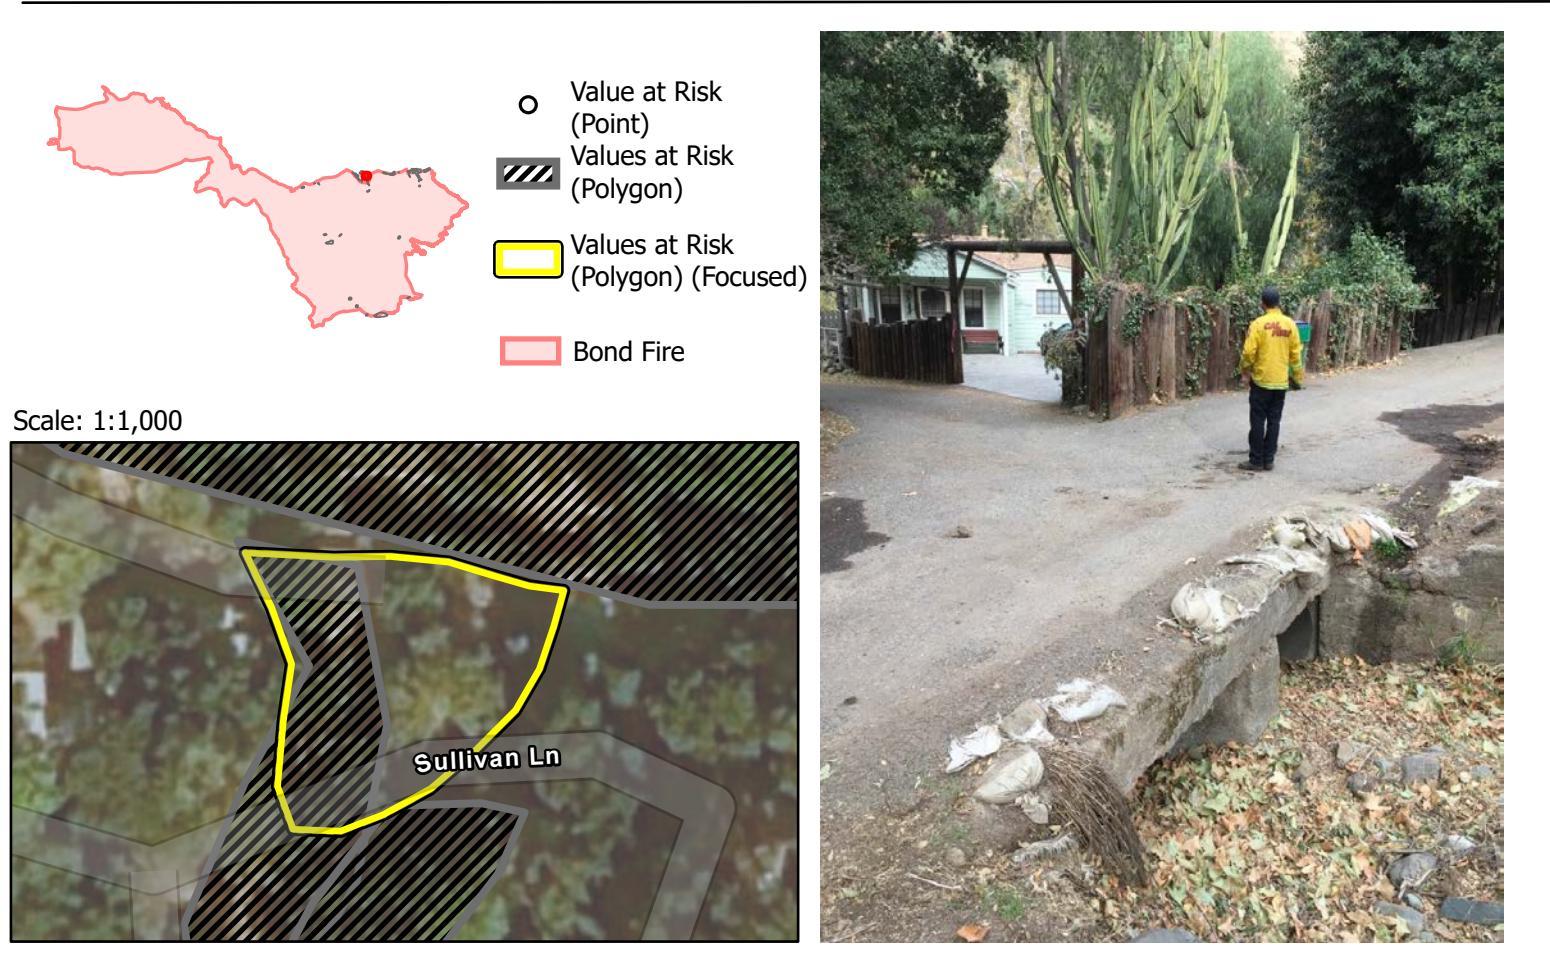
Description: Consider Evacuation. This is a high-hazard area.

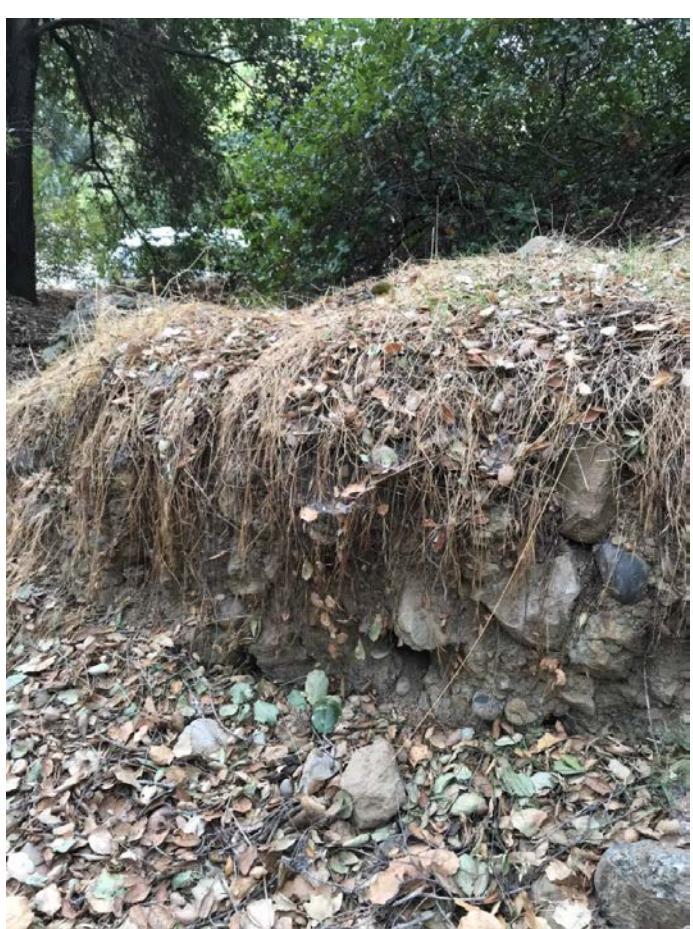
Description: Consider Evacuation. There is a well-documented hazard in this area. A 16-year old girl died at 29442 Silverado Canyon (Old Shadybrook Country Store) in 2005 due to rockfall.
