Watershed Emergency Response Team Evaluation BOND FIRE

CA-ORC-136890

January 8, 2021

BOND FIRE – WERT ASSESMENT EXECUTIVE SUMMARY

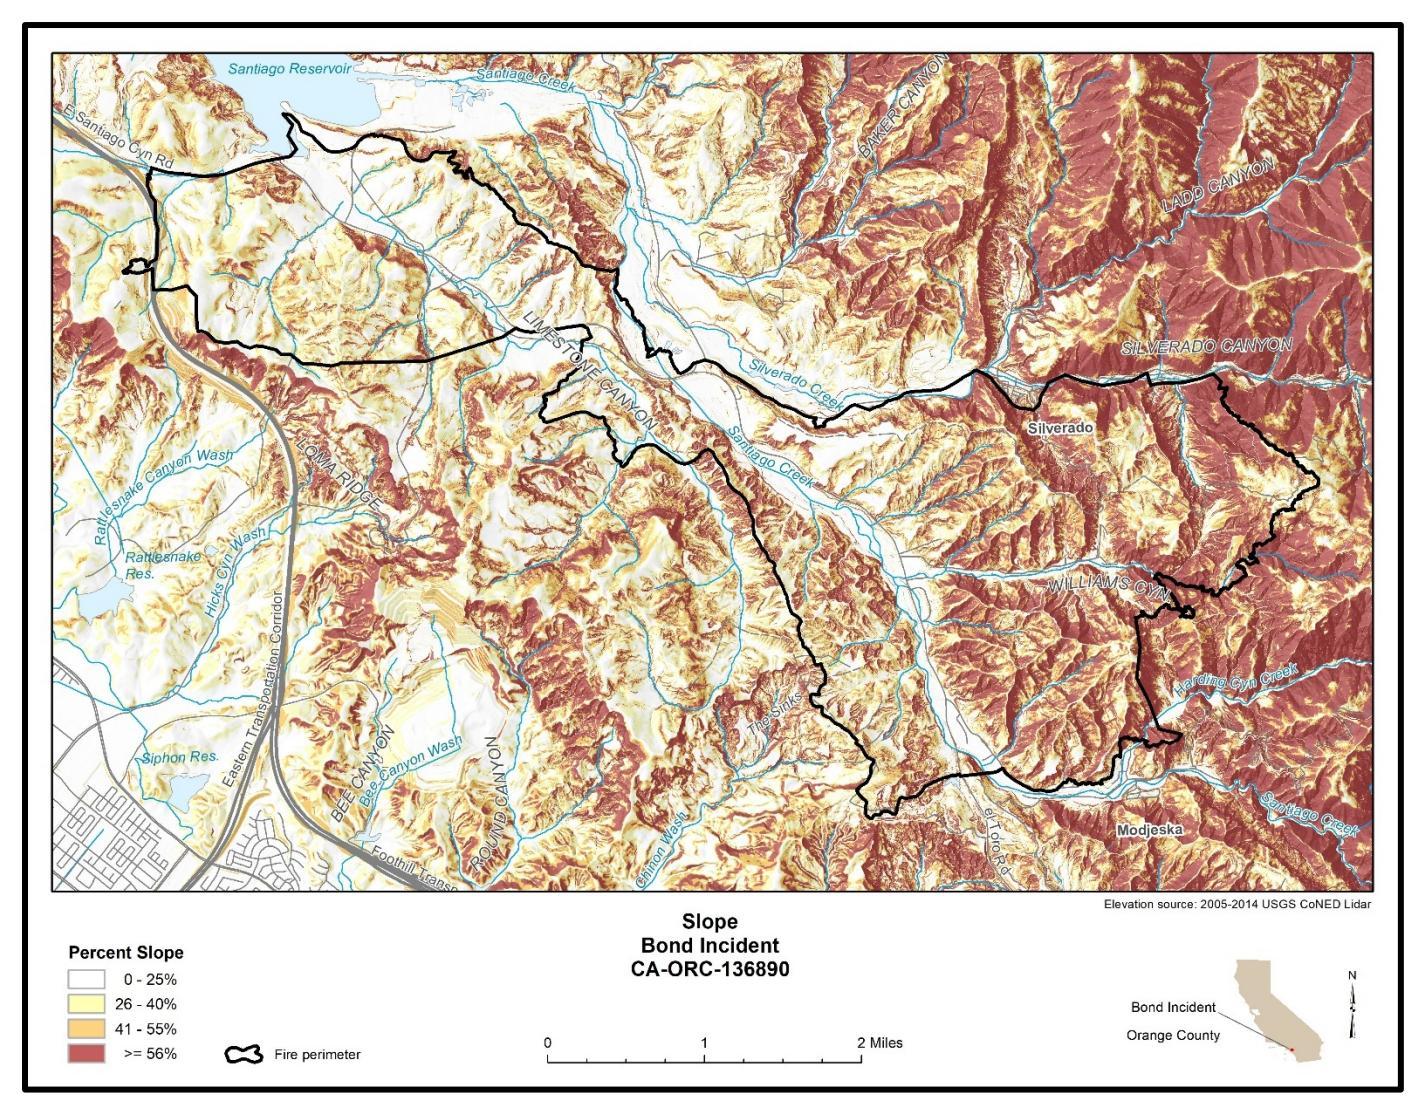
Figure 2. Slope map for the Bond Fire burned areas. Areas over 55 percent slope (i.e., red shading) have a higher likelihood of landsliding and dry ravel.

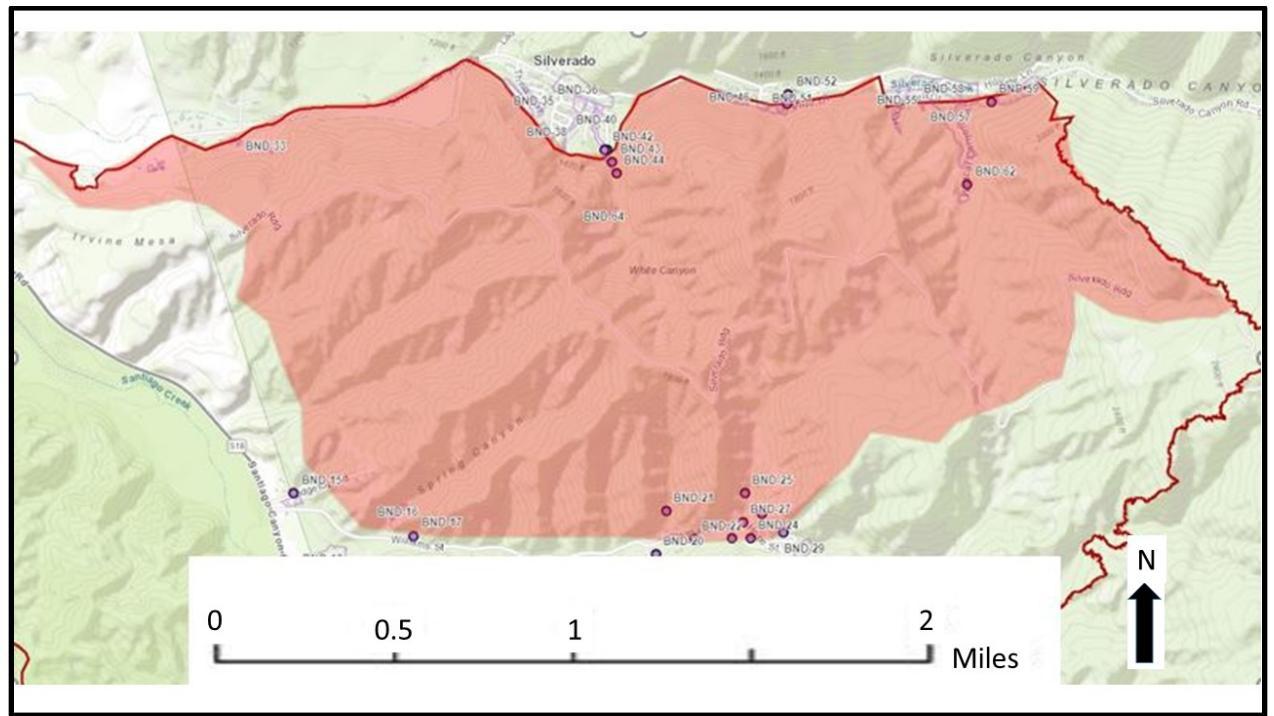
Fire history indicates that a large proportion of the Bond Fire footprint within Silverado Canyon has not burned for decades prior to 2020. About half of that unburned area last burned in 1975, and the other half of the area within Silverado Canyon has no recorded fire history (Figure 4). The northern portion of Williams Canyon has a similar fire history to Silverado Canyon, with half of that northern area burning in the 1975 fire, and the other portion with no recorded fire history. The combined area of the Bond Fire footprint that has not burned since at least 1975 is 1,490 acres, and is shown in a clip below with Values-at-Risk indicated. The western portion of the clip below also recorded the most severe soil burn severity of the Bond Fire.

Figure 4. A close-up of the area, shaded in red, within the Bond Fire footprint with either no recorded fire history, or lasted burned in 1975. We posit that watershed response might be higher within this area due to higher fuel loading and potentially increased soil damage.

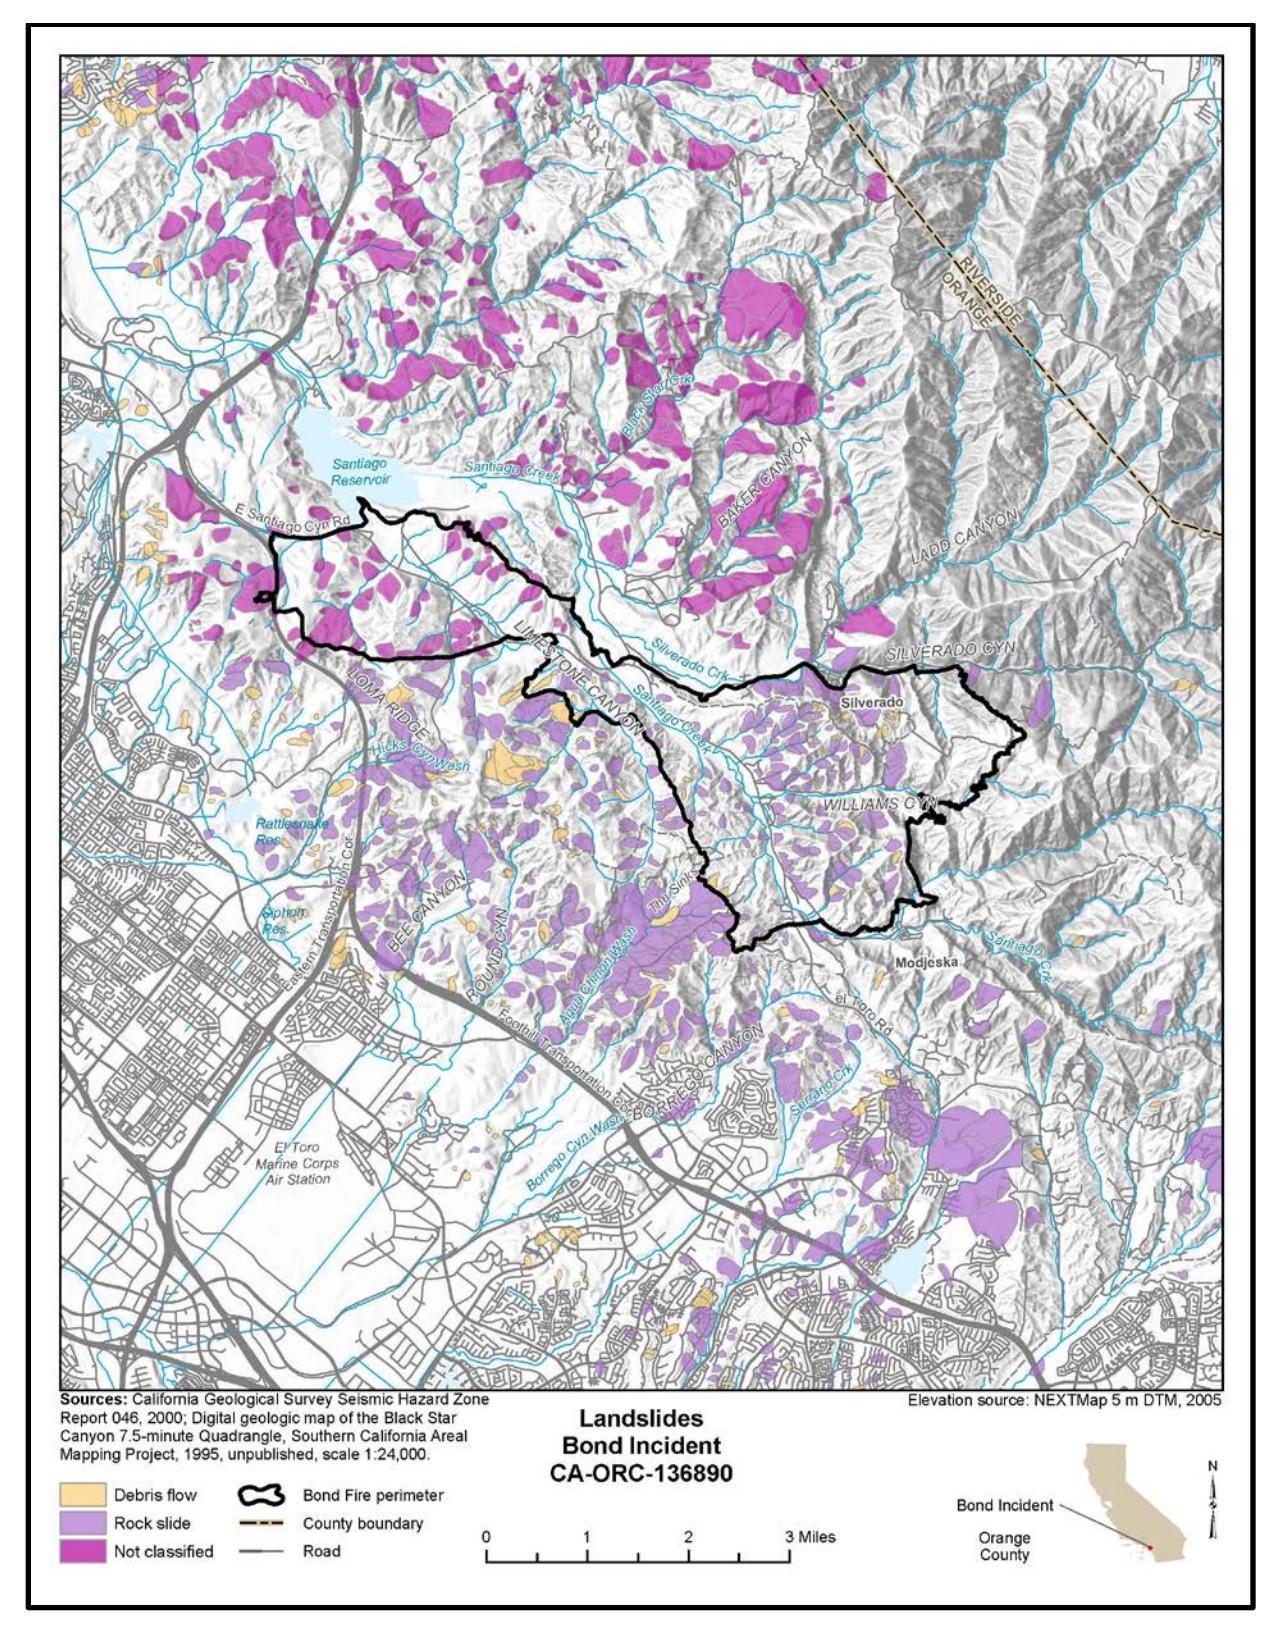
Figure 6. Landslide map for the Bond Fire.

The Cretaceous rocks crop out in the eastern portion of the burned area and are comprised of interbedded resistant, bluff and steep slope forming, graywacke and conglomerate interbedded with highly fractured, slope forming argillite. The resistant bedrock readily forms bluffs and steeply inclined hillslopes that are often undermined by friable argillite. The steep slopes are prone to rockfall, talus slope formation, and shallow and deep-seated landslide processes. Bedrock is generally highly fractured in outcrops and combined with strong ground shaking generated on nearby active faults; deep-seated rockslides are common (Figure 6, Landslide Map). Bedding planes in the Cretaceous bedrock predominantly dip northeast and southwest and appear more steeply inclined in the eastern portion of the burned area that underlie White, Wildcat, upper Williams, and Harding Canyons. In the eastern portion of the burned area, where geologic strata is steeply dipping in the same direction as the hillslope, slope stability is significantly reduced. This adverse dipslope (dipping out of the slope) condition is a common casual mechanism of landslide initiation during regional landslide inducing precipitation events, strong ground shaking, and/or as a result of land use/development activities. To the west, Cretaceous strata becomes less steeply inclined and instability more commonly occurs on steeply inclined end slopes (anti-dipslope) (Figure 6).

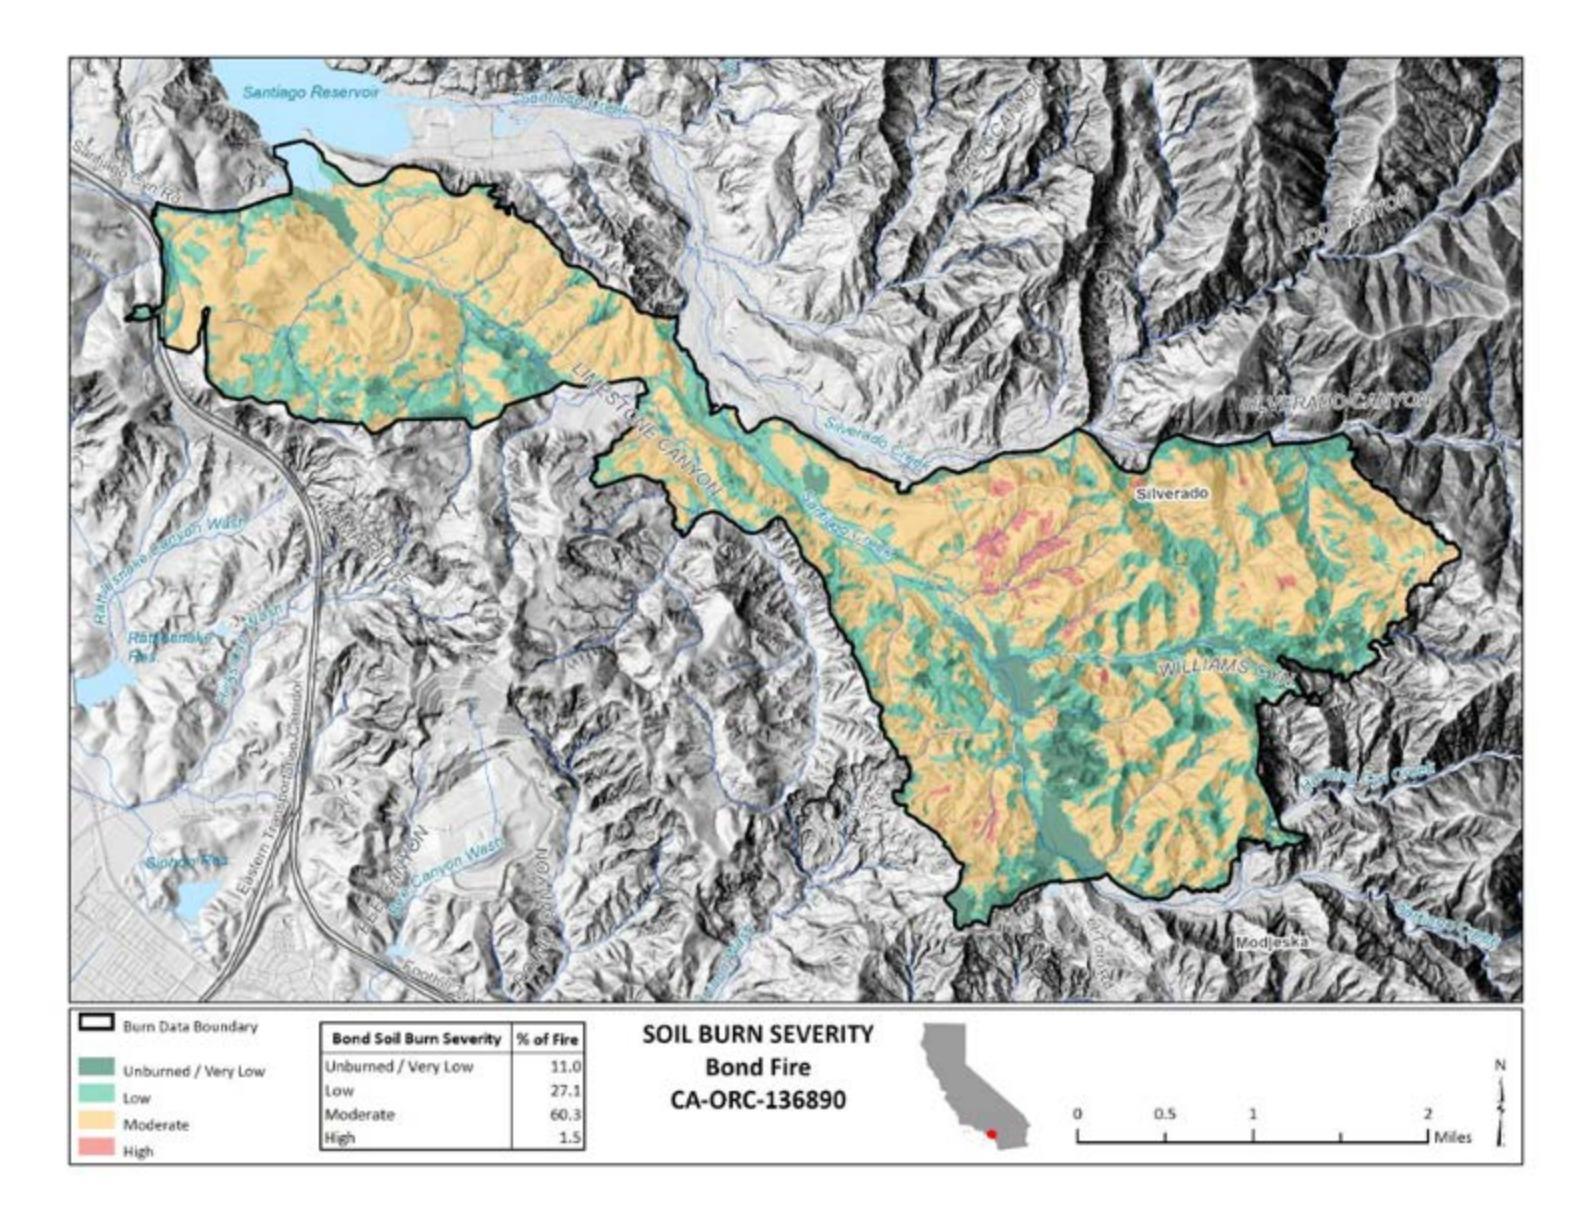
Figure 8. Soil burn severity map for the Bond Fire burned area.

The Bond Fire burned areas are characterized by a high proportion of moderate and high soil burn severity (Table 5). Within the Bond Fire footprint, sixty two percent of the burn area is composed of moderate (60.3 percent) and high (1.5 percent) soil burn severity, with the remaining 38 percent in low (27.1 percent) or very low/unburned (11 percent) soil burn severity. The preponderance of moderate and high soil burn severity indicates a very high potential for post-fire watershed response. Some of the highest proportions of moderate and high soil burn severity are north of Williams Canyon in unnamed tributary streams that drain directly into Santiago Creek (Figure 8). While the majority of areas that registered as "high" soil burn severity occurred in basins with low, or no, populations downstream, the preponderance of moderate soil burn severity, the over-steepened hillsides and the naturally erosive nature of the geology are expected to potentially generate debris flows throughout the Bond Fire burn area.

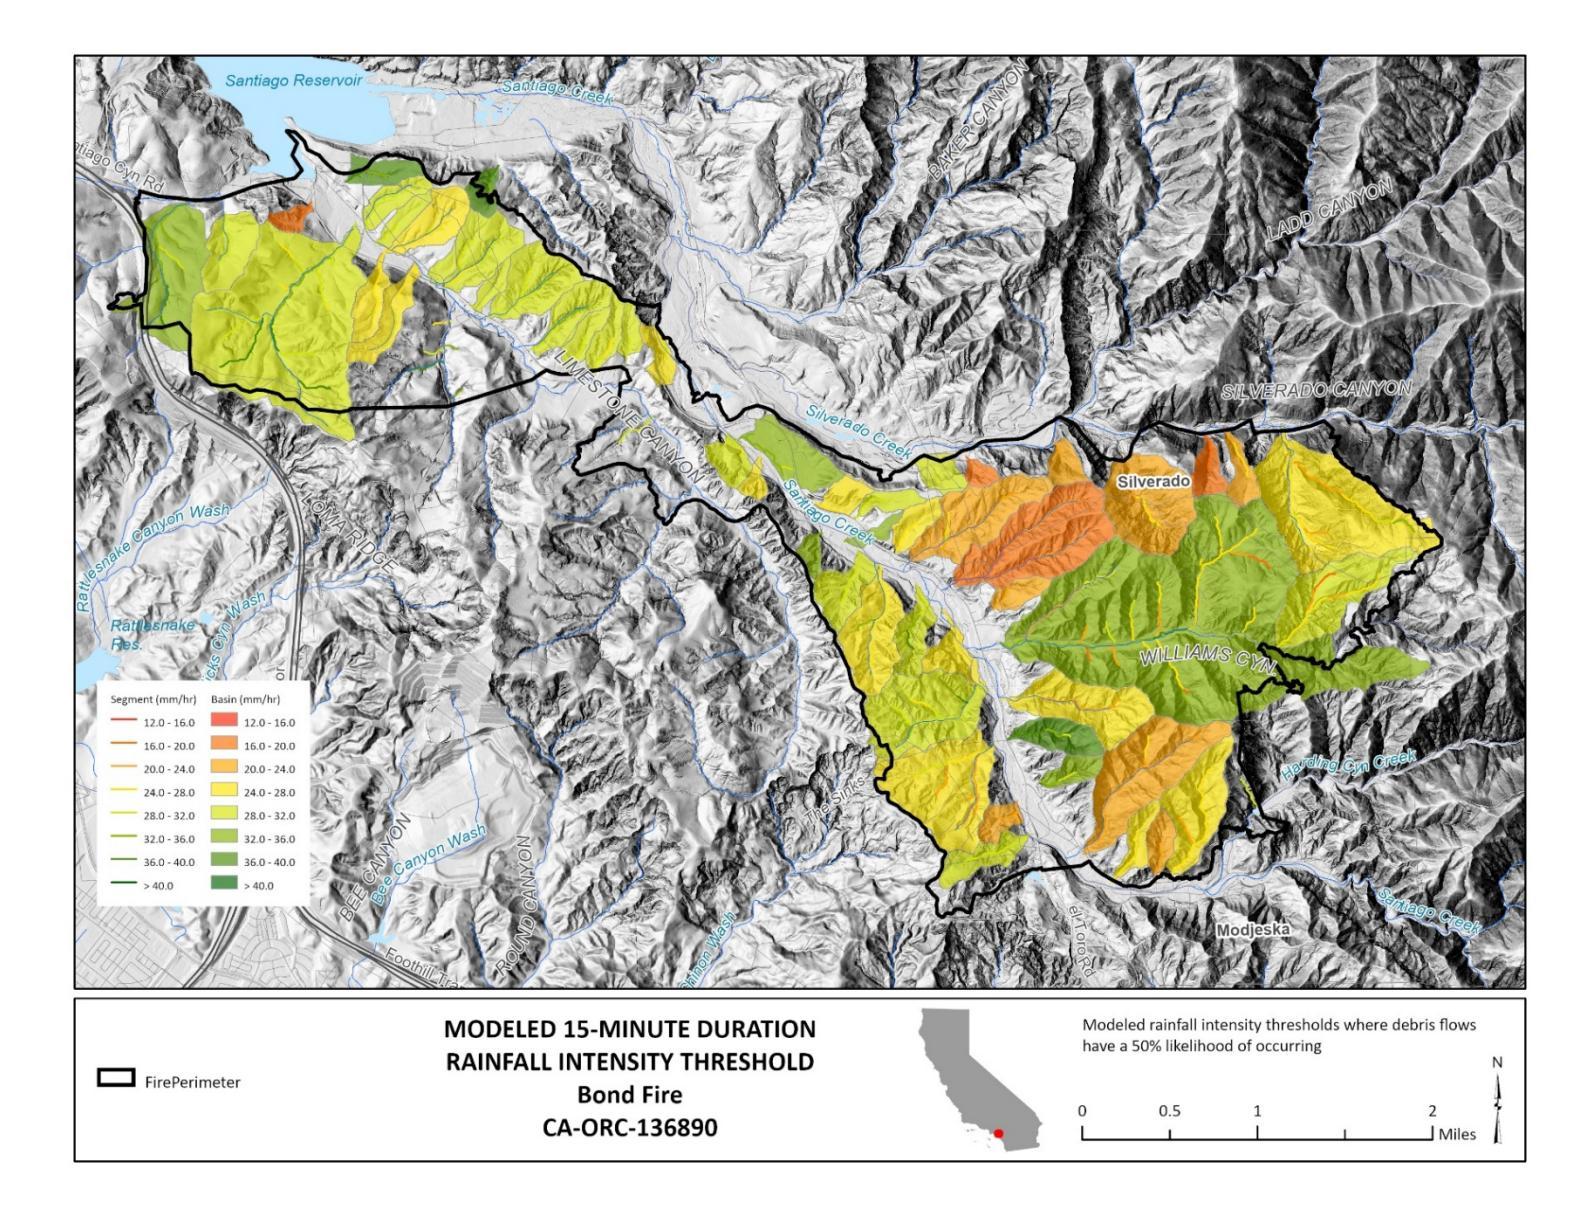
Spatially explicit thresholds indicate that the predicted range in 15-minute duration rainfall intensities at the basin scale range from 16 mm hr⁻¹ to 40 mm hr⁻¹. Figure 10 shows the predicted 15-minute duration rainfall intensities at the basin and segment scale for the Bond Fire. Some of the lowest modeled 15-minute duration thresholds (<24 mm hr⁻¹) are associated with basins and segments draining towards developed portions of Silverado Canyon.

Figure 10. Modeled 15-minute duration rainfall intensity thresholds for the Bond Fire. The rainfall intensities shown in the figure have a probability of 50% for triggering a debris flow.

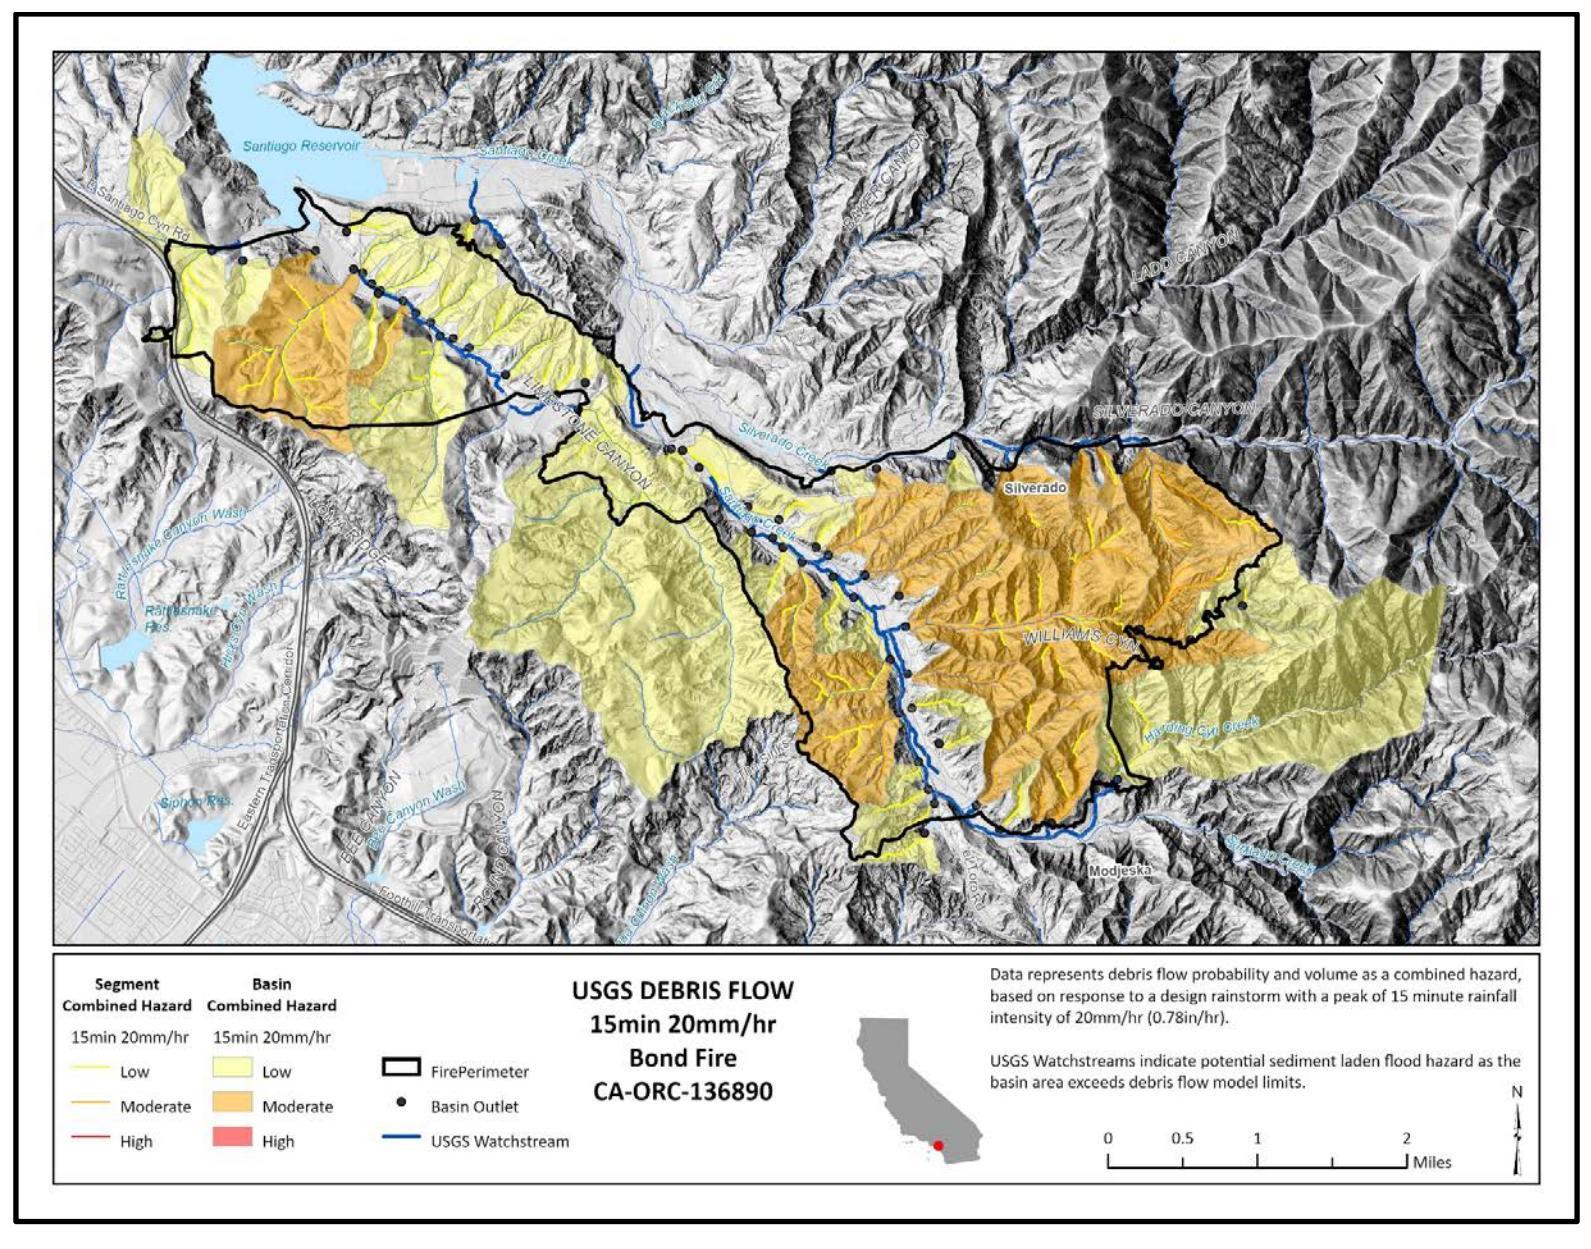
Figures 12 and 13 and indicate that the combined debris flow hazard is moderate to high for areas containing critical VARs at rainfall intensities ranging from 20-32 mm hr⁻¹, with much of the burned area with VARs having a moderate to high combined debris flow hazard at a rainfall rates of 32 mm hr⁻¹. Overall, areas of moderate to high combined hazard are dominated by higher probabilities of initiating debris flows rather than high debris volumes. This is due to the smaller basin areas and relatively low relief in the burned area, which limits volumetric yield within the USGS debris flow model.

Figure 12. Combined debris flow hazard on the Bond Fire for the 20 mm hr⁻¹ (0.78 in hr⁻¹) 15-minute storm event.

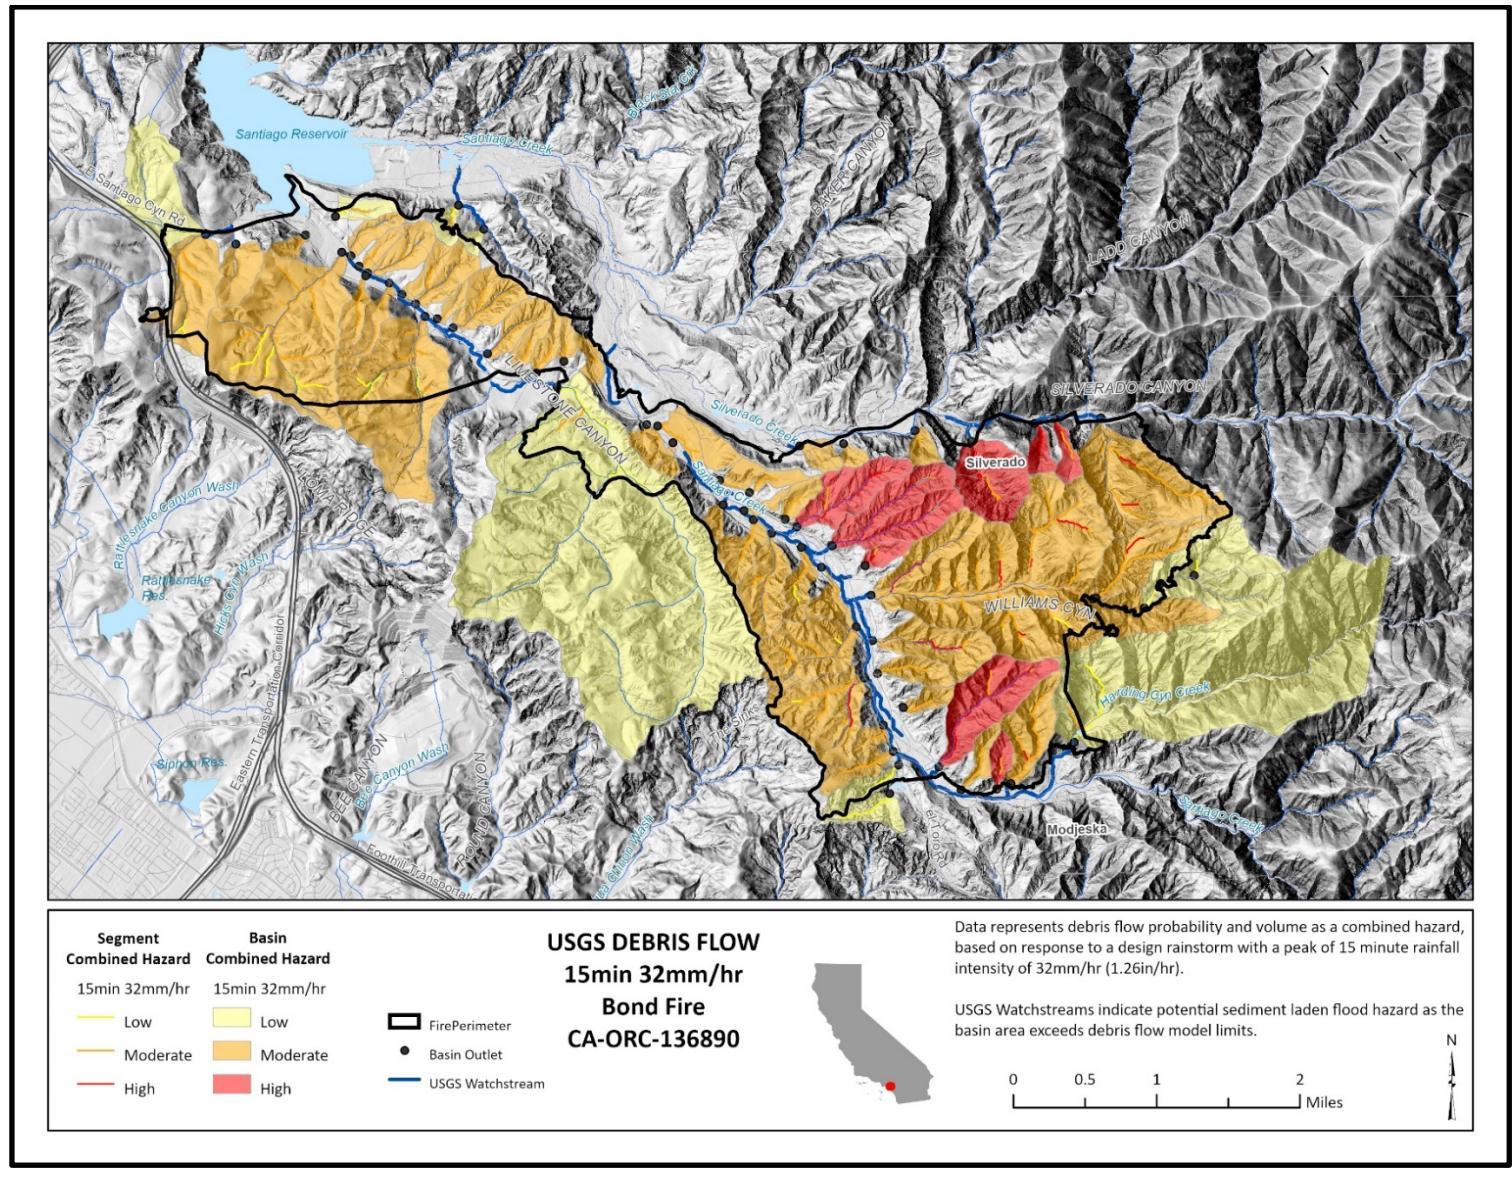
Figure 13. Combined debris flow hazard on the Bond Fire for the 32 mm hr⁻¹ (1.26 in hr⁻¹) storm.

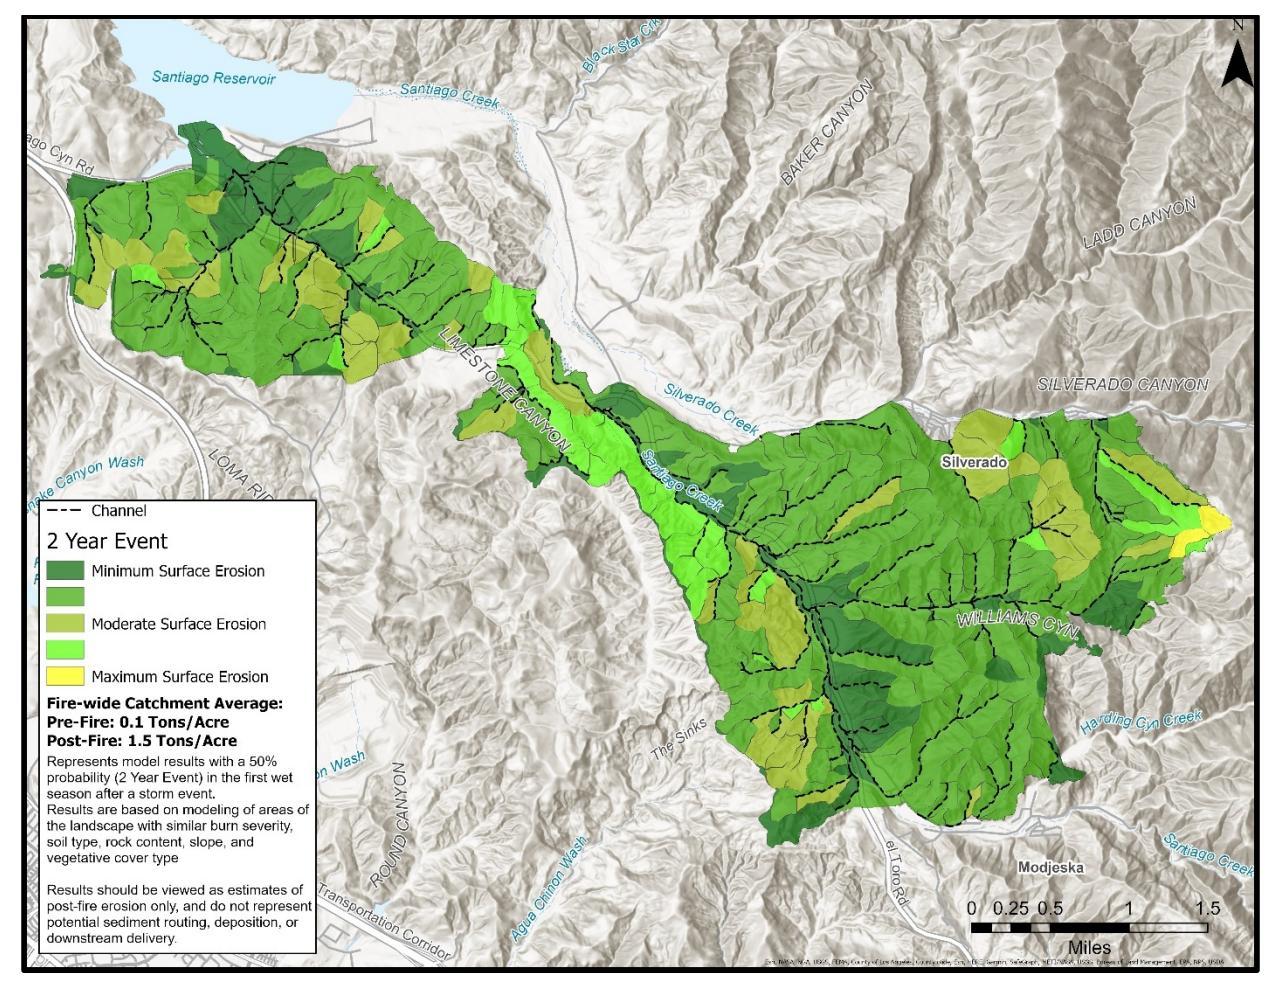
The ERMiT model indicates relatively large increases between pre- and post-fire sediment production. Sediment production from the 2-year storm event will increase by more than an order of magnitude (Figure 14), whereas the 10-year storm will increase sediment production by a factor of four (Figure 15). The absolute values predicted by ERMiT correspond well with empirical data collected from the 2007 Santiago Fire (Wohlgemuth et al., 2010), indicating that the model did a reasonably good job of representing post-fire erosion processes.

Figure 14. Bond Fire predicted surface erosion rates for the 2-year storm event using the Erosion Risk Management Tool (ERMiT).

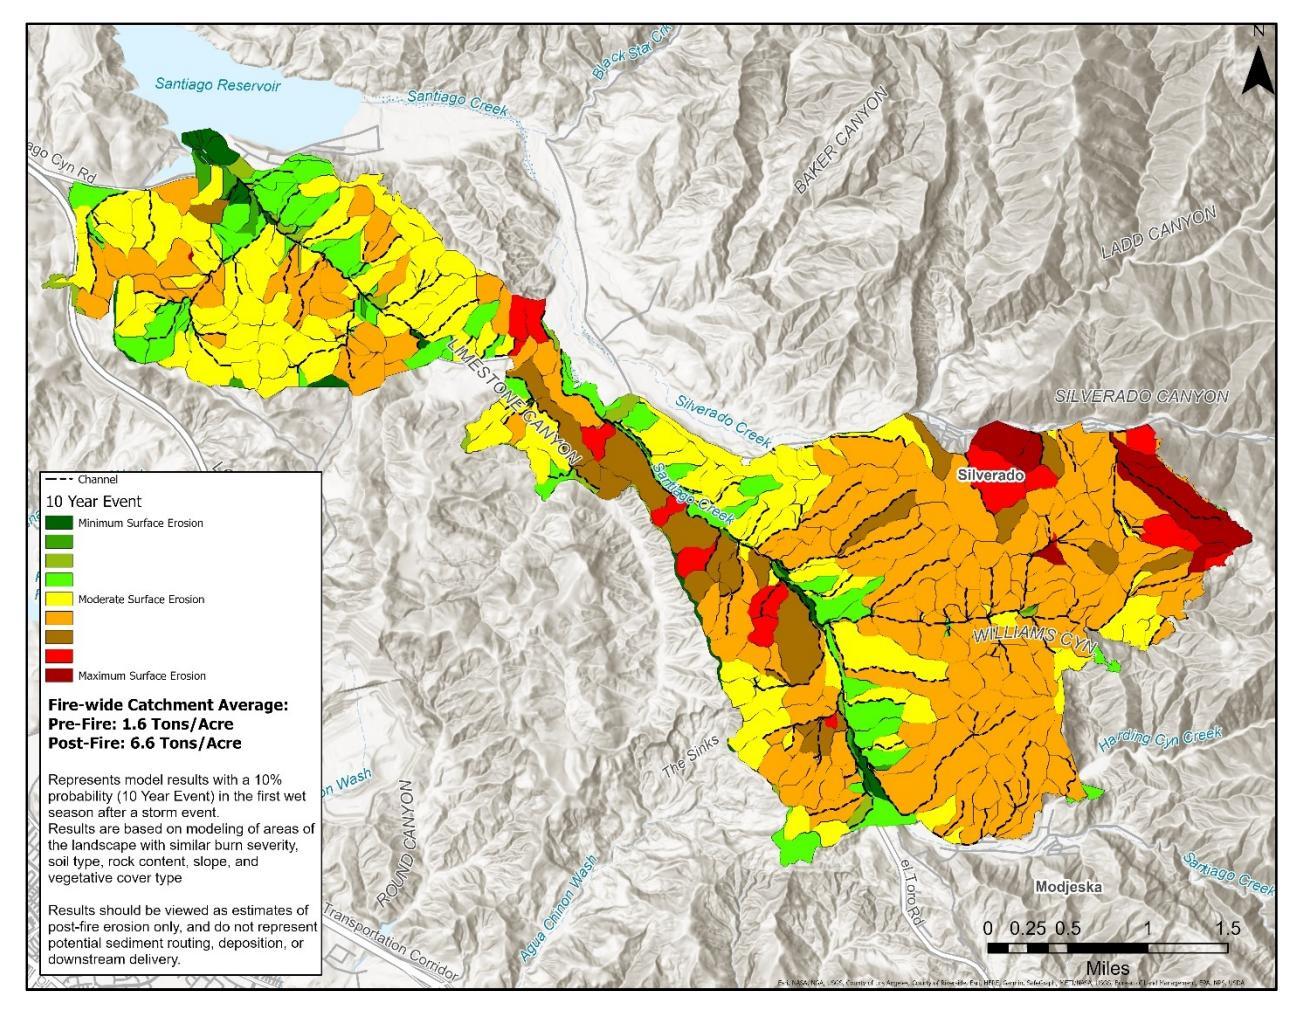
Figure 15. Bond Fire predicted surface erosion rates for the 10-year storm event using the Erosion Risk Management Tool (ERMiT).

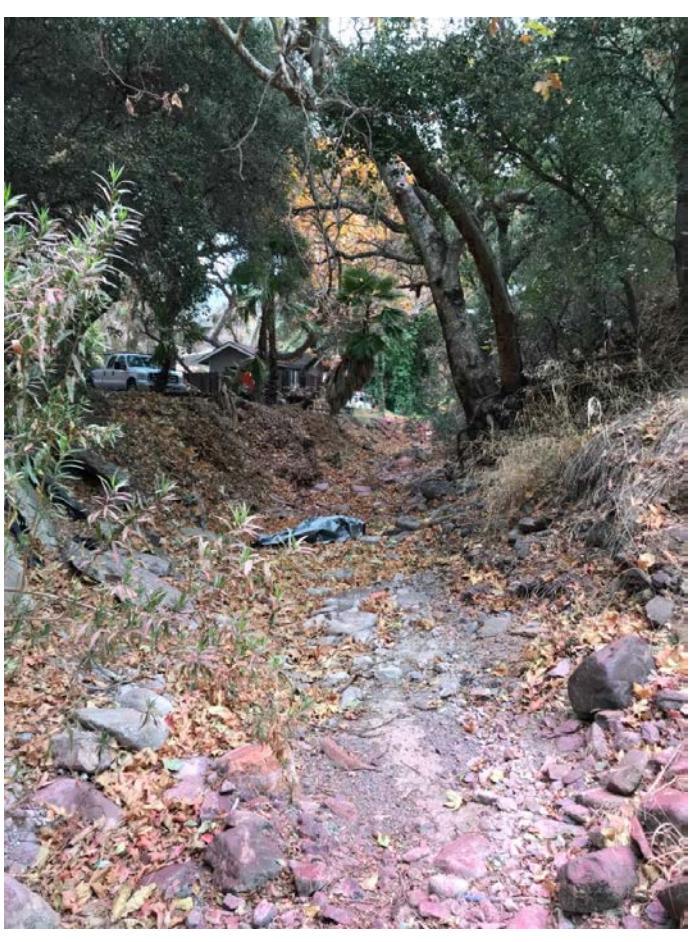
Field Observation House and outbuildings on low surface adjacent stream, small burn area *or Potential Hazard:* upstream. Local bulking from burned steep raveling slopes upstream of residences could deposit and bulk flows and cause avulsion.

Potential Hazard to Life: moderate

Potential Hazard to Property: high

Description: Consider evacuation in high flow events.

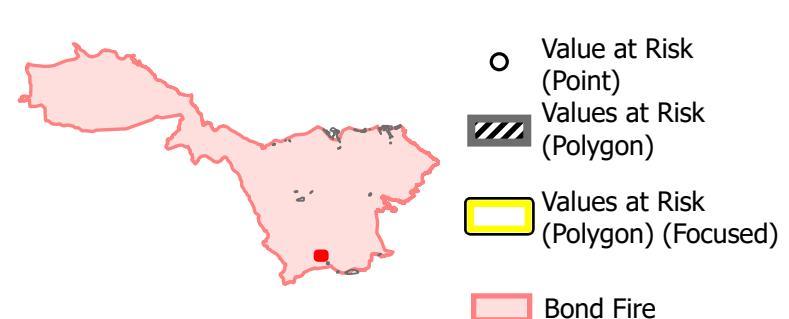
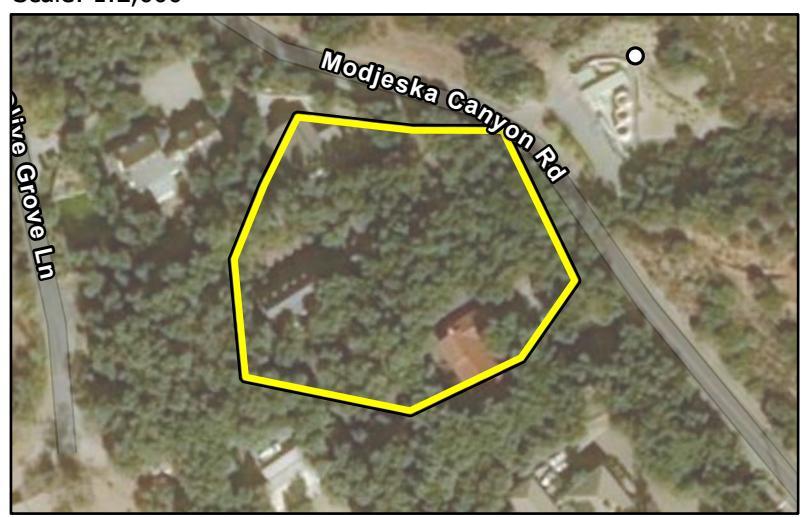
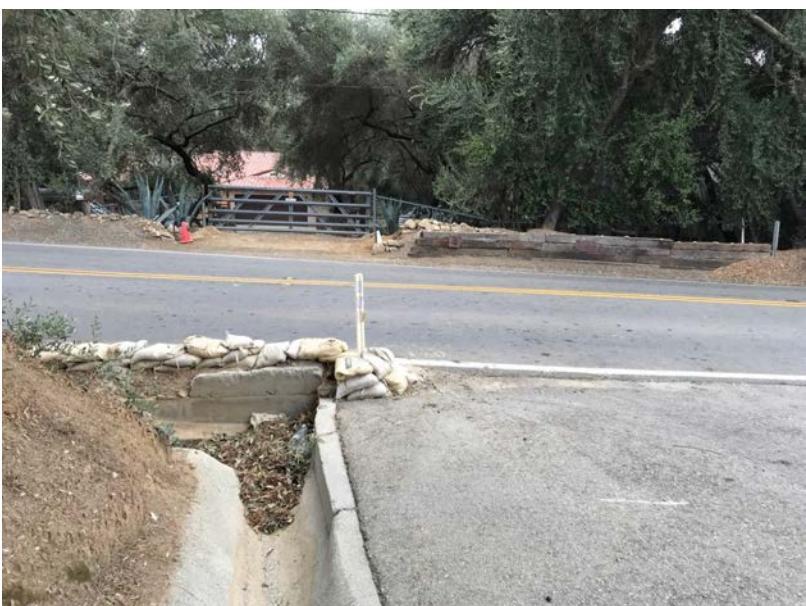
Field Observation House in flow path of unmodeled catchment. Berming at driveway suggests *or Potential Hazard:* prior issues.

Potential Hazard to Life: moderate

Potential Hazard to Property: high

Description: Structure at driveway entrance appears to be under construction.

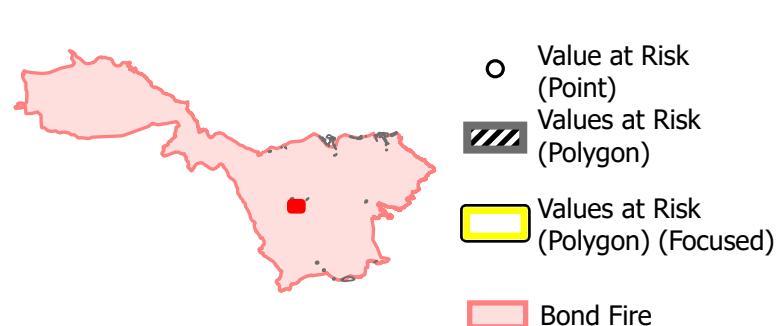
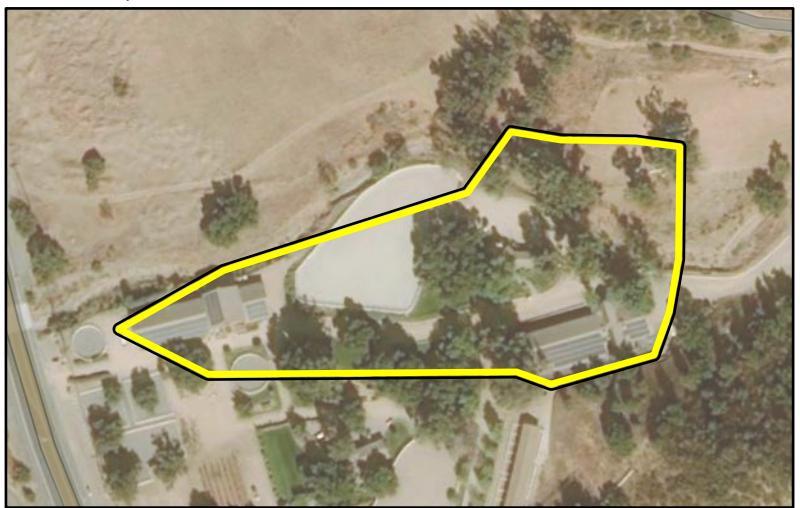
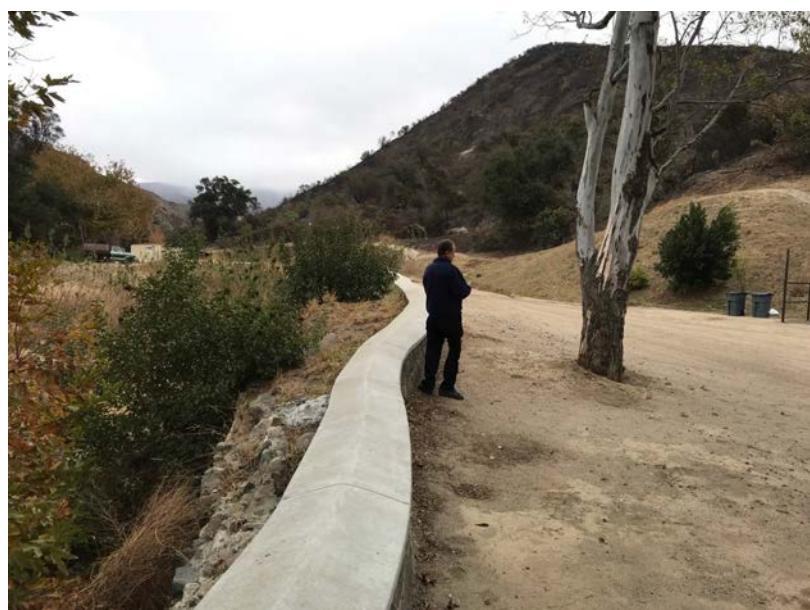
Field Observation Houses and business structures in floodplain. History of flooding and debris in *or Potential Hazard:* barn and around house.

Potential Hazard to Life: moderate

Potential Hazard to Property: high

Description: There is potential for reducing hazard with appropriately designed and installed deflection structure. Some work has been done to reduce flood hazards on Williams Creek.

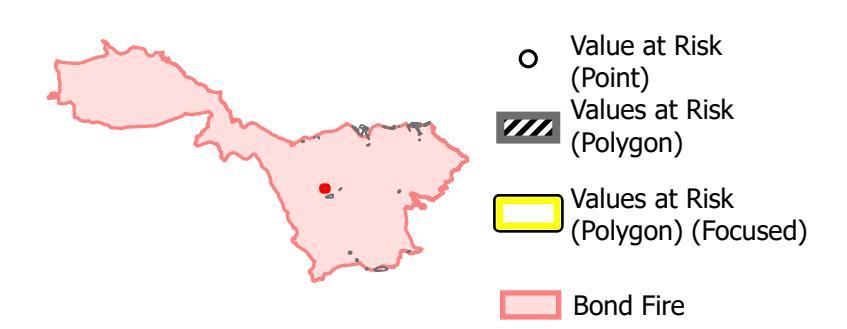
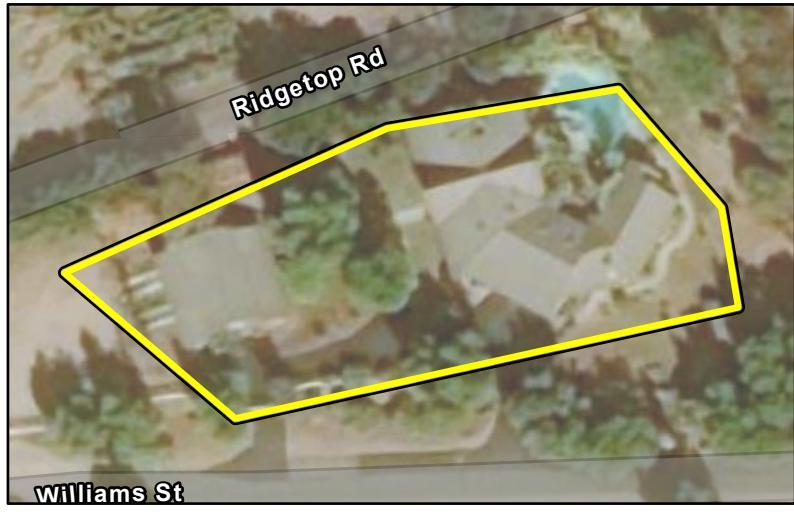
Field Observation House on low surface adjacent to flow path. *or Potential Hazard:*

Potential Hazard to Life: moderate

Potential Hazard to Property: high

Description: Culvert upstream of home appears undersized and could cause flow to home.

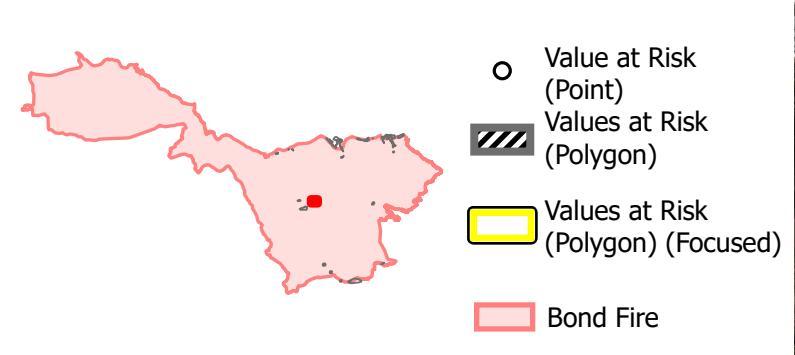
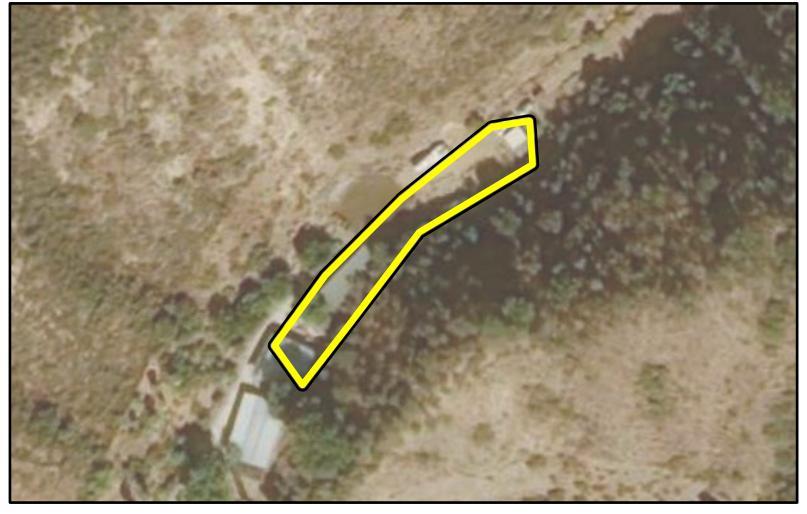
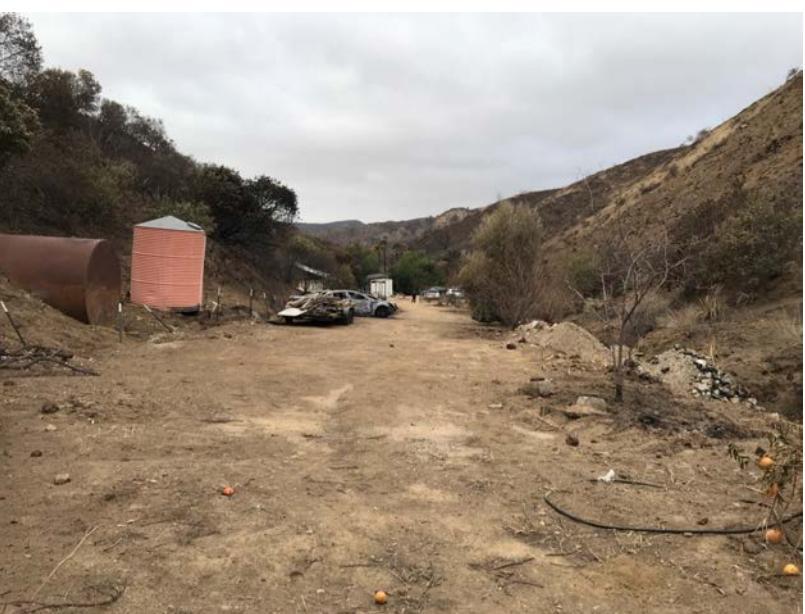
Field Observation Residence and outbuilding in flow path / channel. *or Potential Hazard:*

Potential Hazard to Life: moderate

Potential Hazard to Property: high

Description: Consider evacuation in predicted high flow events.

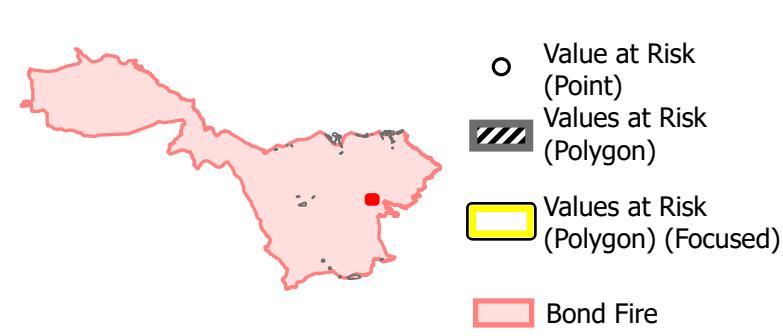
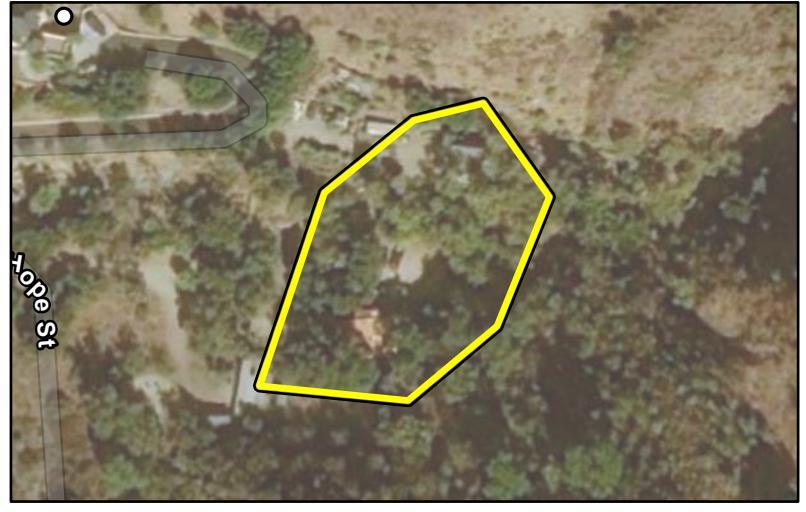
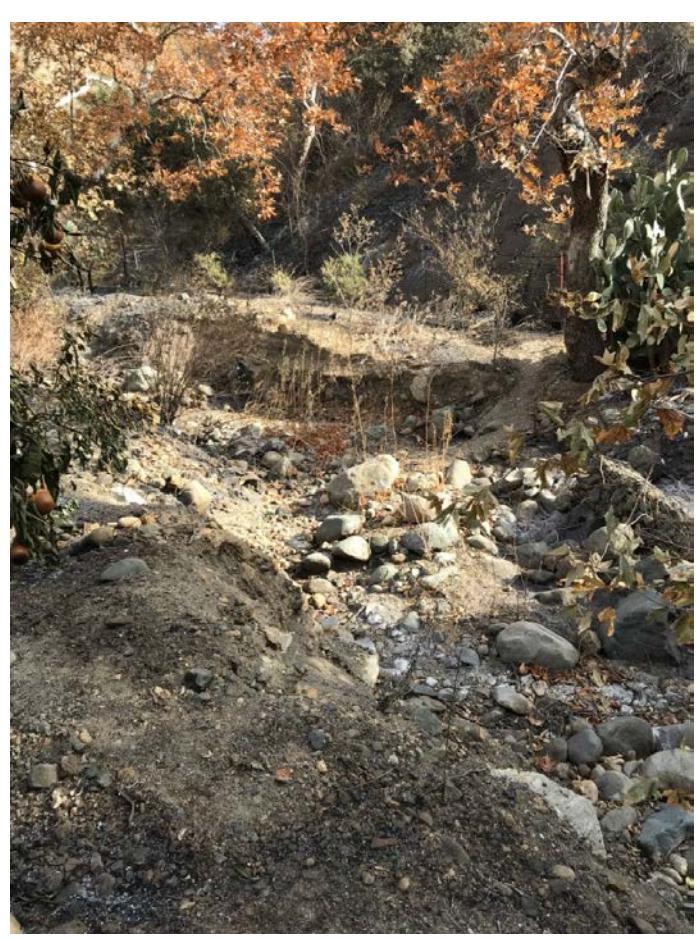
Field Observation Residences on flood plain adjacent to channel with history of flooding. *or Potential Hazard:* Downslope of steep unmodeled catchments with history of flows and flooding.

Potential Hazard to Life: high

Potential Hazard to Property: high

Description: Consider evacuation in high flows.
