Watershed Emergency Response Team Evaluation BOND FIRE

CA-ORC-136890

January 8, 2021

BOND FIRE – WERT ASSESMENT EXECUTIVE SUMMARY

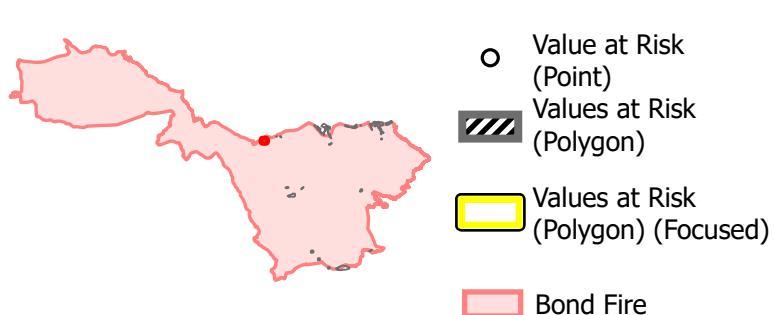
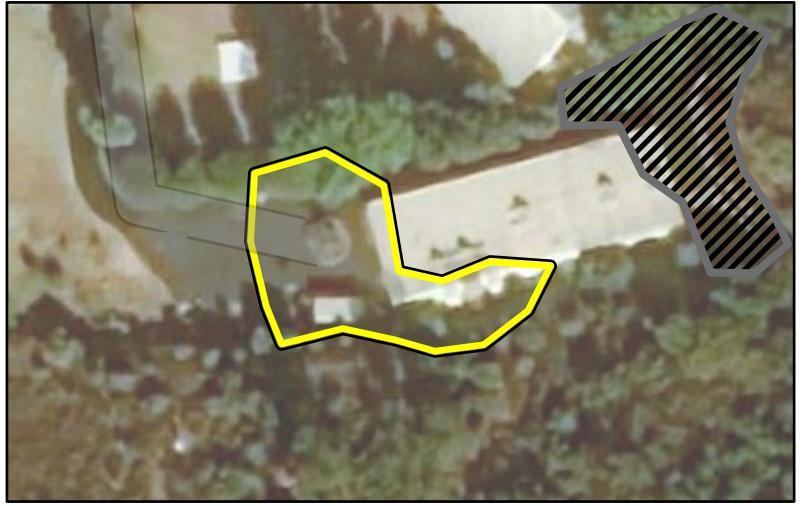
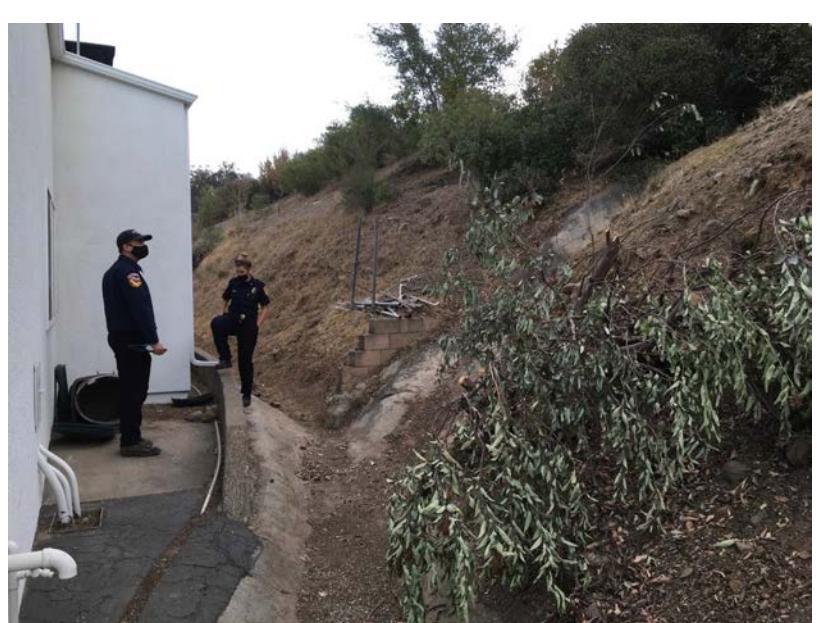
Field Observation Mud and debris and flooding potential risk to rear of church auxiliary building. *or Potential Hazard:* Window facing drainage on west rear side needs to be hardened and drainage channel needs to be cleared of existing debris and storage materials. Sandbag west-side entrance.

Potential Hazard to Life: moderate

Potential Hazard to Property: moderate

Description: Consider Evacuation.

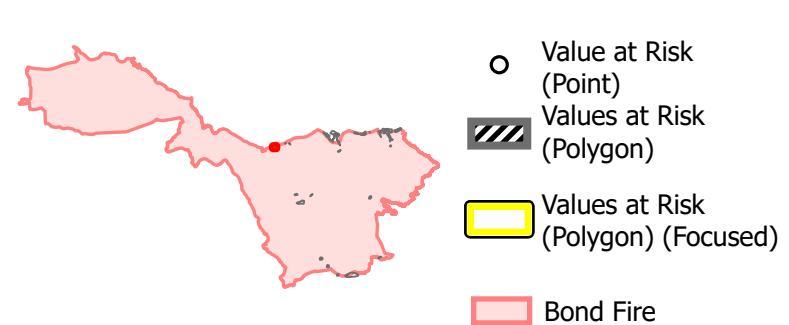
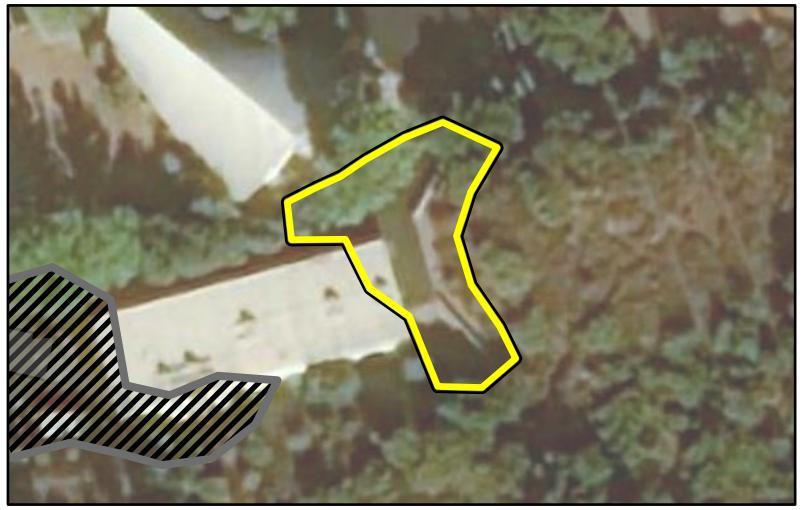
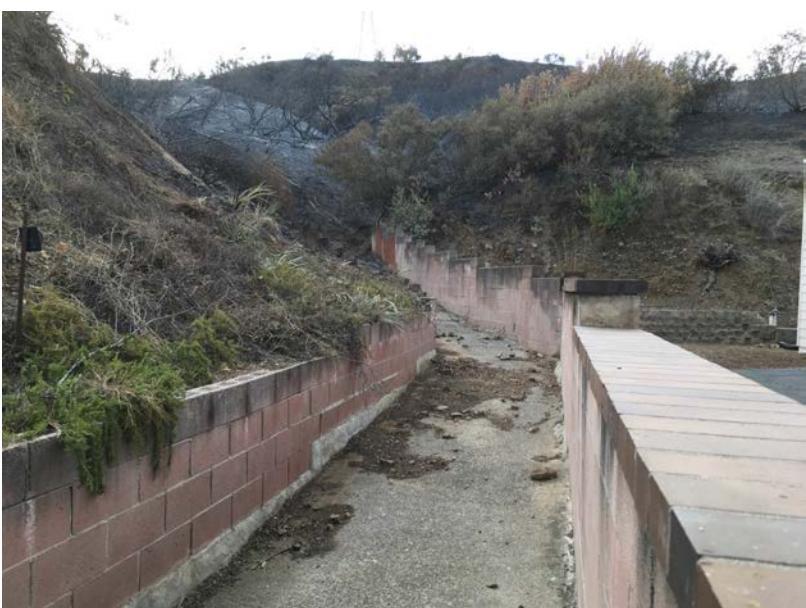
Field Observation Drainage channel may be overtopped with debris, mud, and hyperconcentrated or *Potential Hazard*: flow. Drainage channel is aimed at corner of church auxiliary building.

Potential Hazard to Life: moderate

Potential Hazard to Property: moderate

Description: Consider Evacuation.

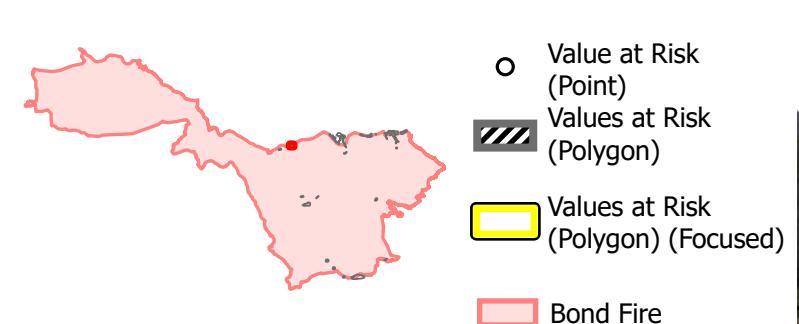
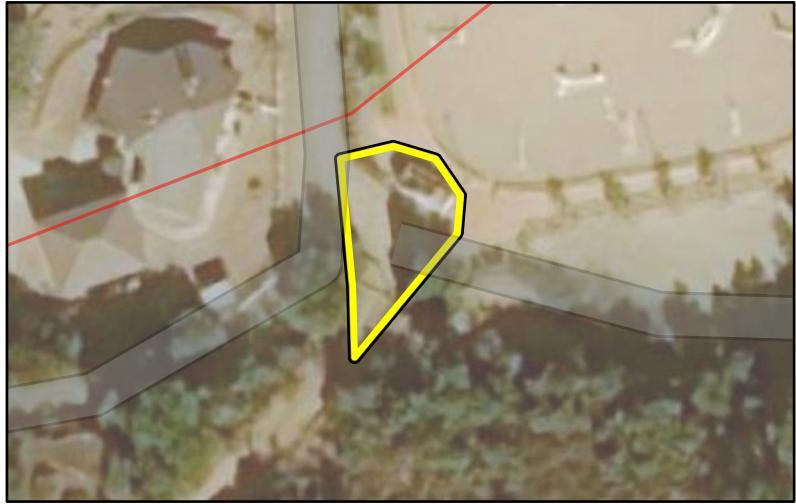
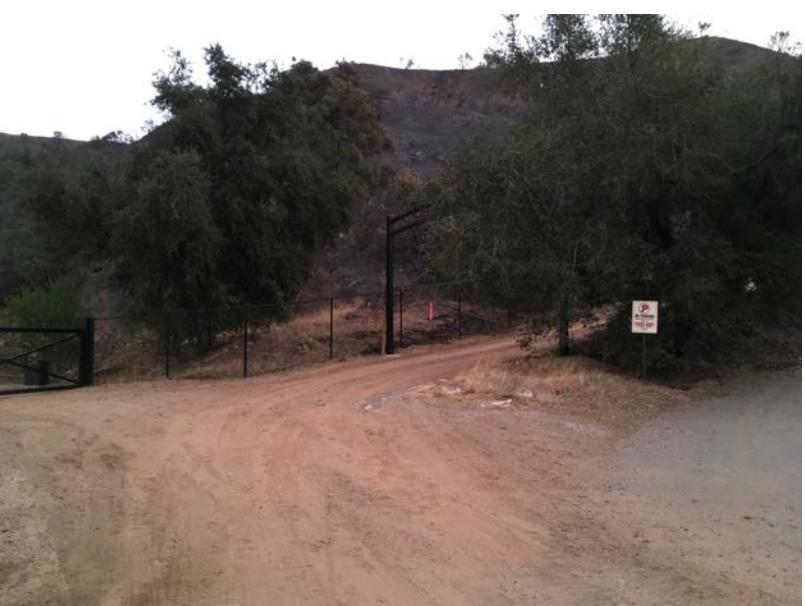
Field Observation Nuisance mud with history of mud and debris on the road way, according to *or Potential Hazard:* report from local resident..

Potential Hazard to Life: moderate

Potential Hazard to Property: moderate

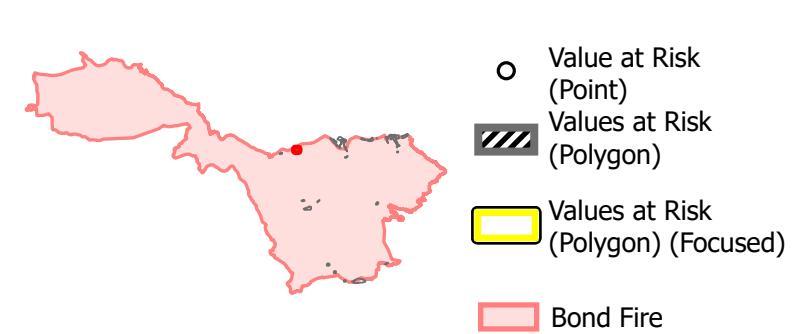
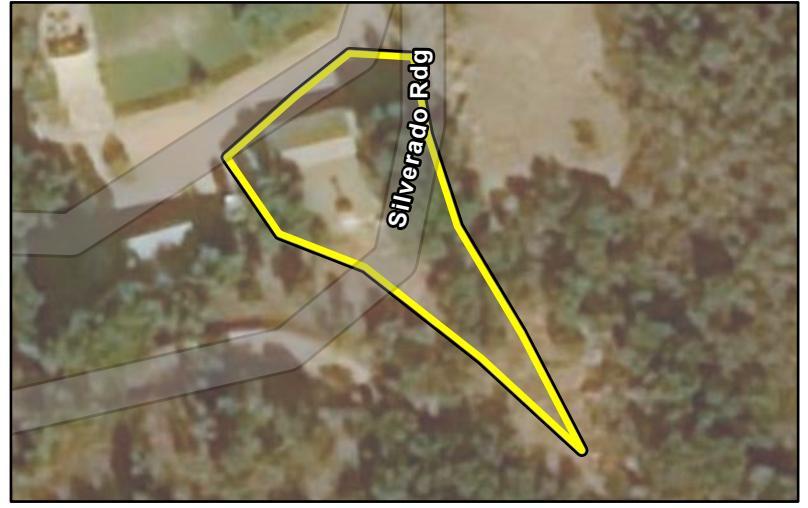
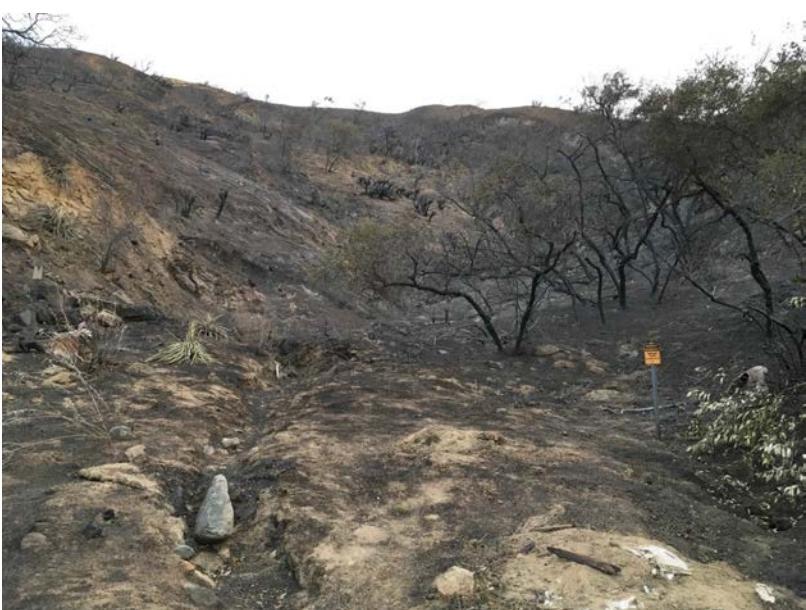
Field Observation Flooding and debris flow. or Potential Hazard:

Potential Hazard to Life: high

Potential Hazard to Property: high

Description: Consider Evacuation. K-rail anchored to ground that will deflect flow coming out of canyon will be a great mitigation, if possible to install. Canyon is not steep; however, drainage empties directly into rear portion of home on the TipToe Ranch.

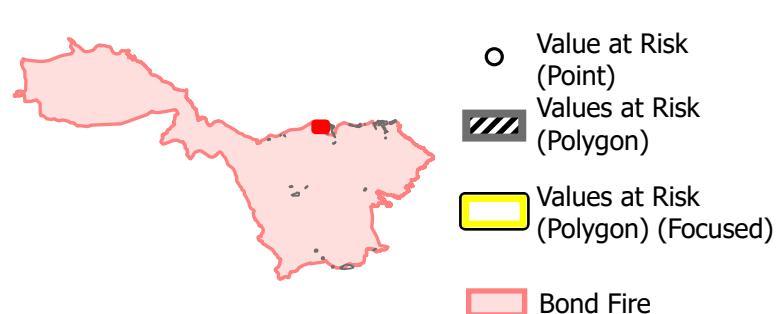
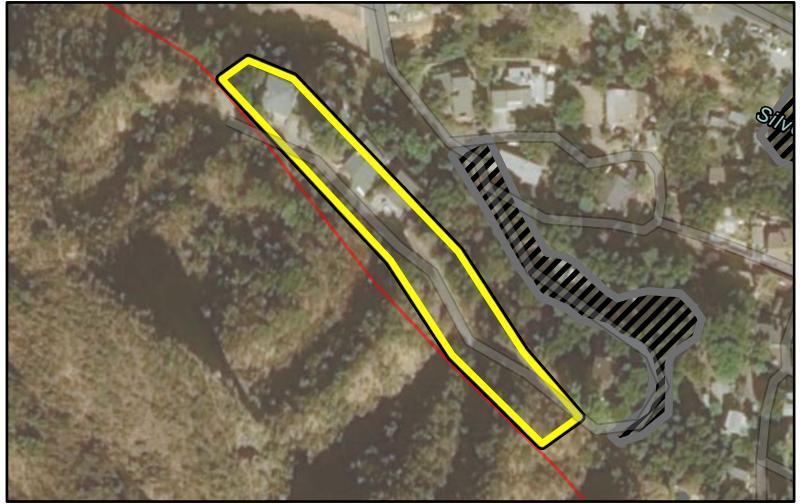
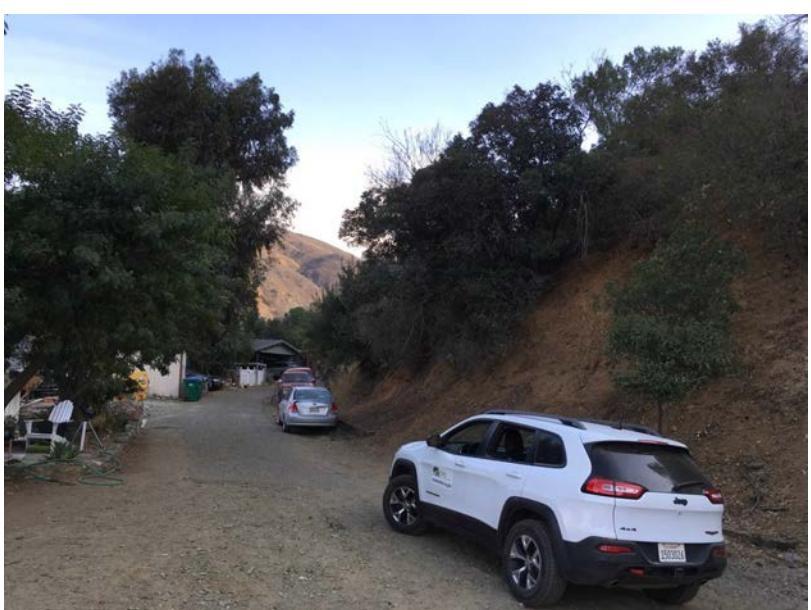
Field Observation Rockfall from north-facing slopes. *or Potential Hazard:*

Potential Hazard to Life: moderate

Potential Hazard to Property: moderate

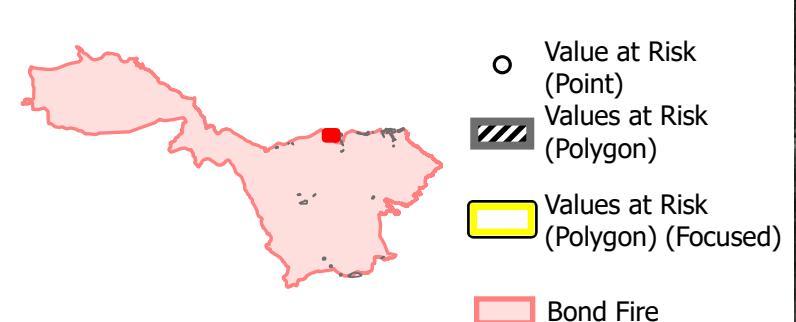
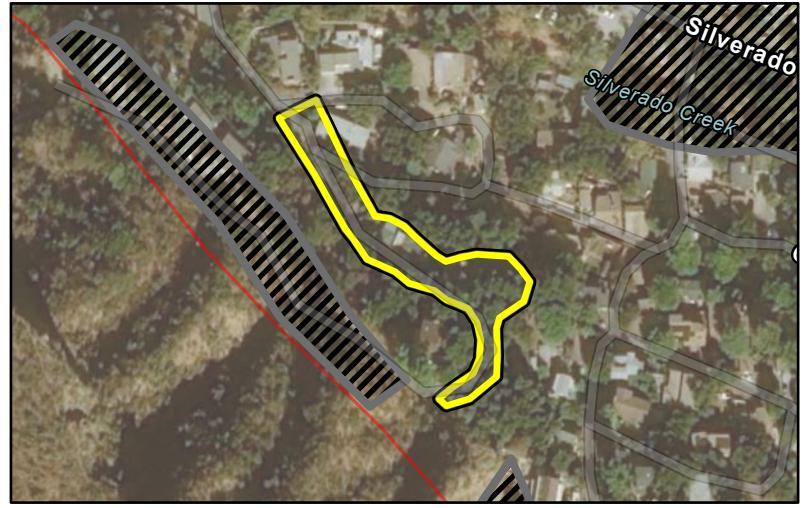
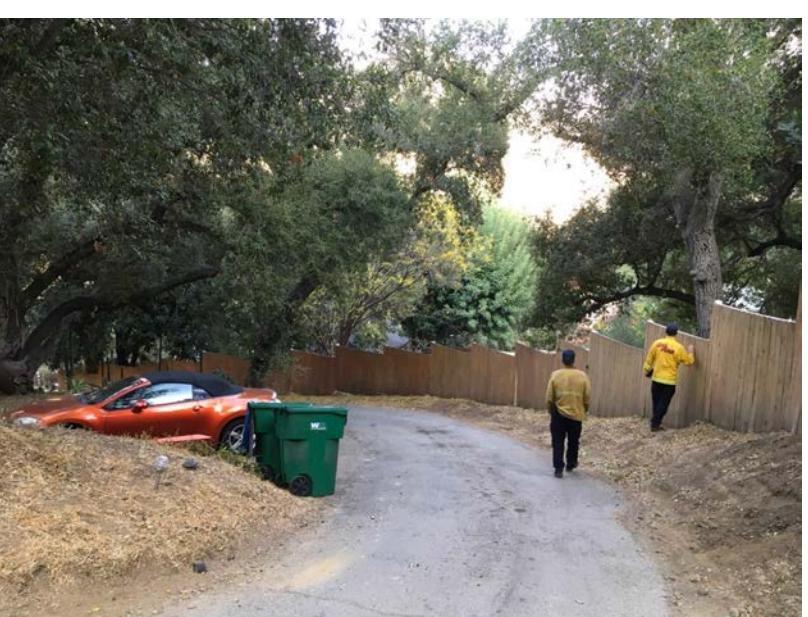
Field Observation Flooding and debris flow capable of damaging roadway and homes. Boulder in *or Potential Hazard:* roadway at bottom of hill on west side of intersection between Thisa Way and Thata Way deposited in 2010 storm according to anecdote from local resident.

Potential Hazard to Life: low

Potential Hazard to Property: moderate

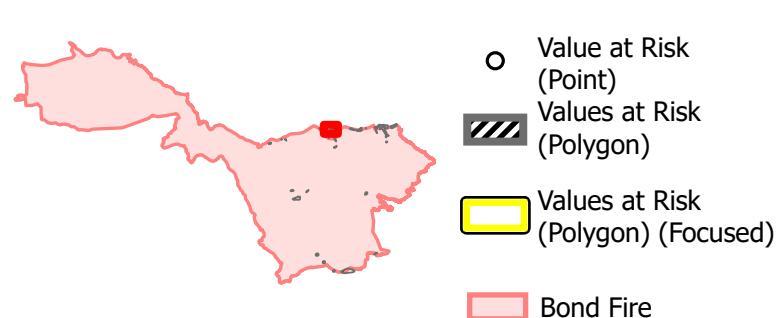
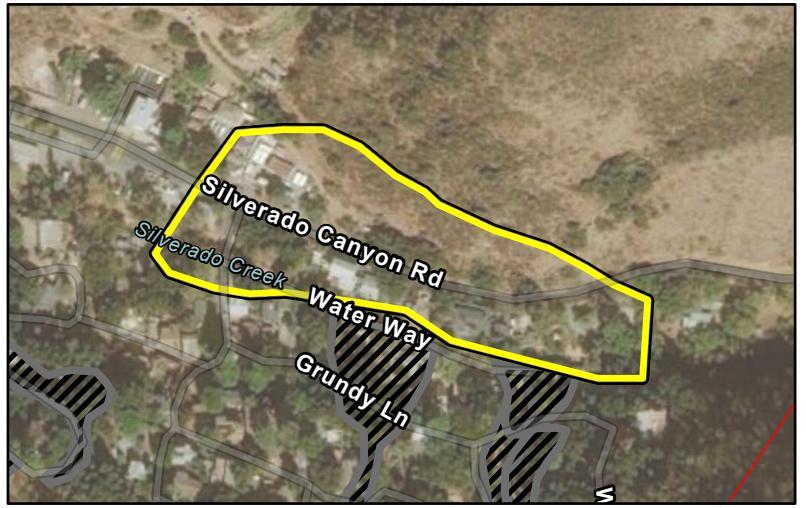
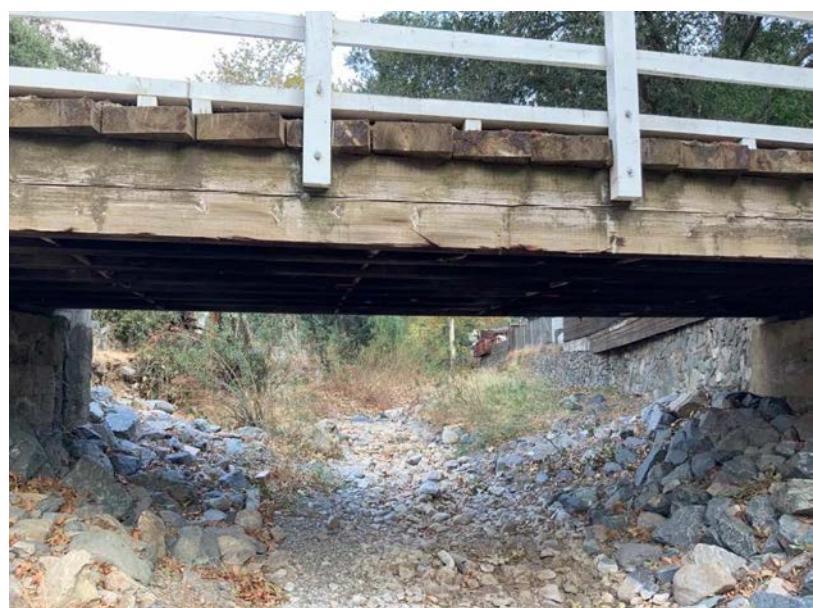
Field Observation Debris from White Canyon may reduce capacity of Silverado Creek, resulting in *or Potential Hazard:* backwatering and flooding of structures and infrastructure in floodplain. Debris may also reduce flow capacity of bridge at Kitterman Drive, causing backwatering and flooding.

Potential Hazard to Life: moderate

Potential Hazard to Property: high

Description: Maintain channels and bridge crossing. County should model flood inundation assuming reduced channel and bridge capacity.

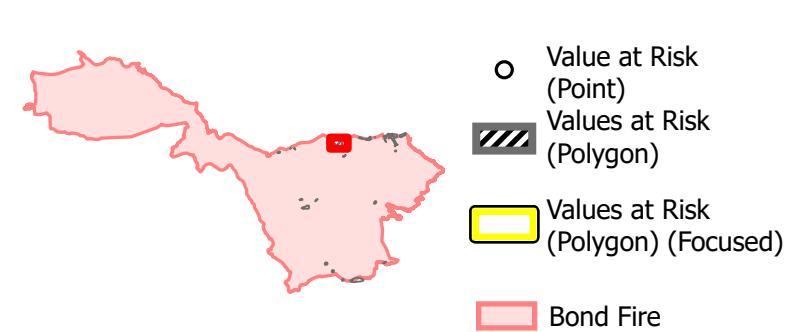
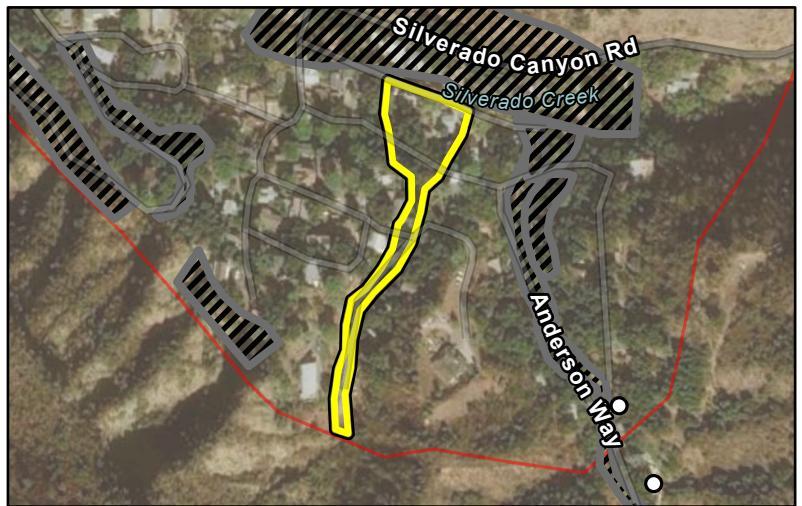
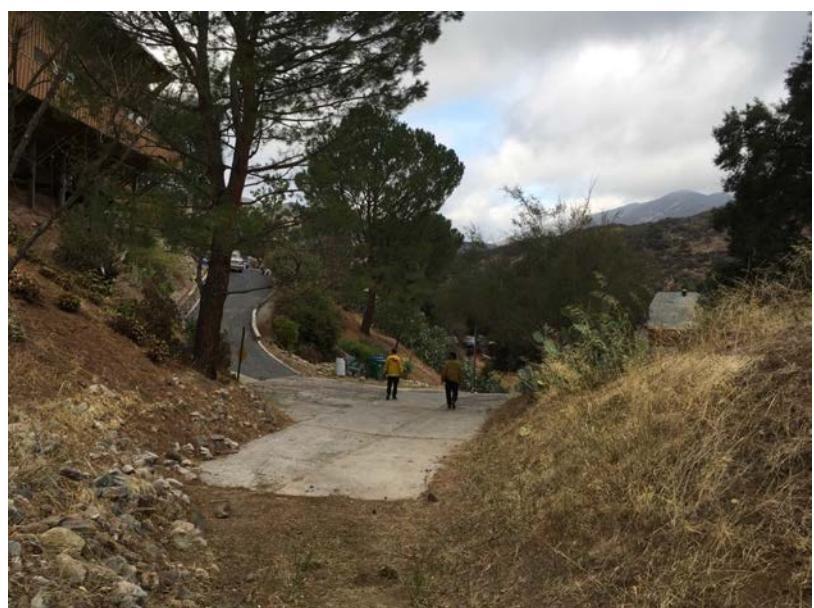
Field Observation Debris and flooding. or Potential Hazard:

Potential Hazard to Life: moderate

Potential Hazard to Property: moderate

Description: It would be optimal to build a debris basin at the top of the roadway where it hits the fire perimeter. 28311 Bond Way will likely face the brunt of the upstream flow before it descends the north slope to impact homes on Grundy Lane sited in flow path.

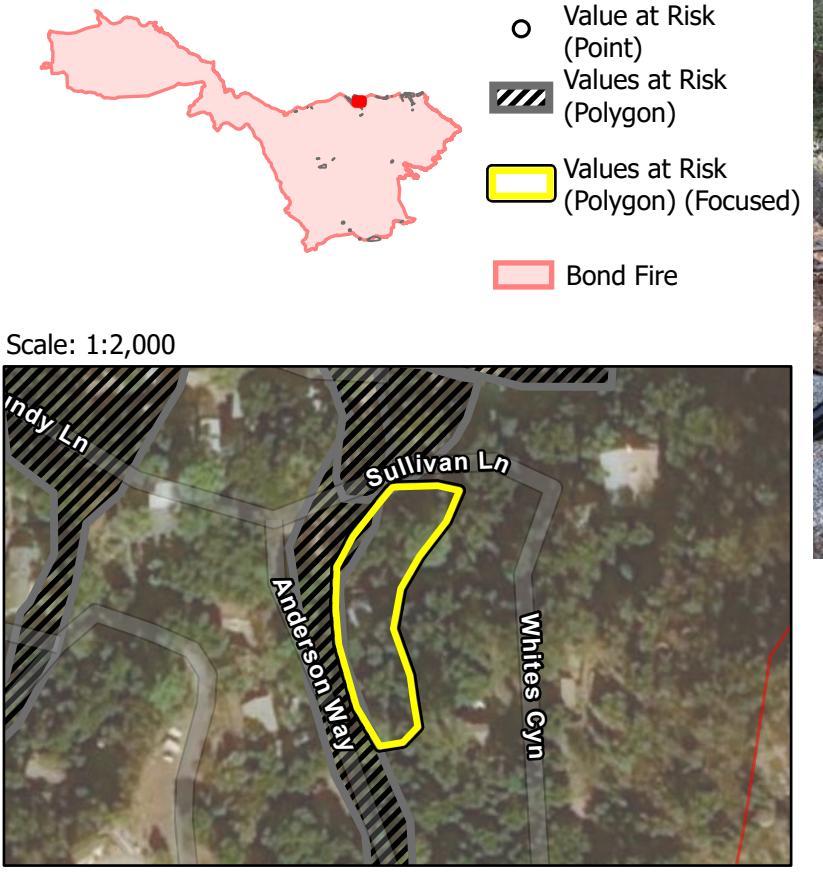
Field Observation Homes in the active floodplain. *or Potential Hazard:*

Potential Hazard to Life: high

Potential Hazard to Property: high

Preliminary Emergency Protective Measures (4): Debris barrier

Description: Consider Evacuation. This is a high-hazard area.

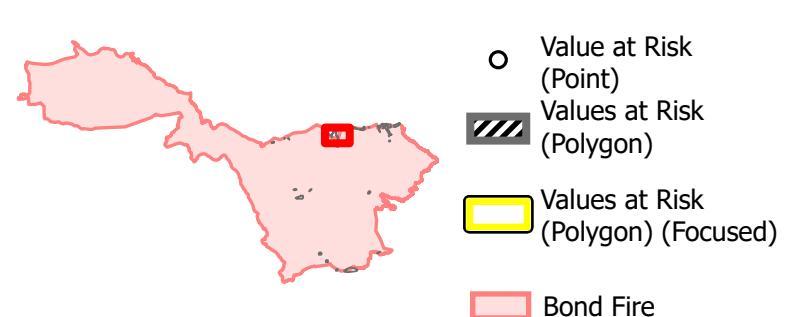
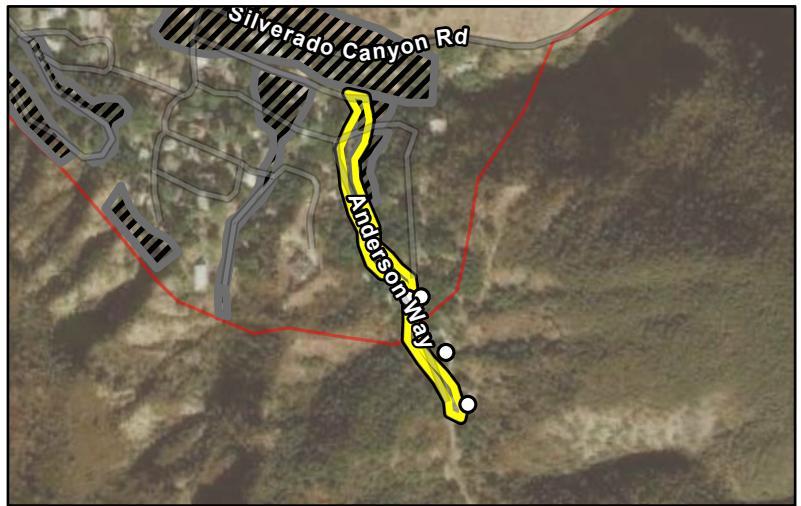
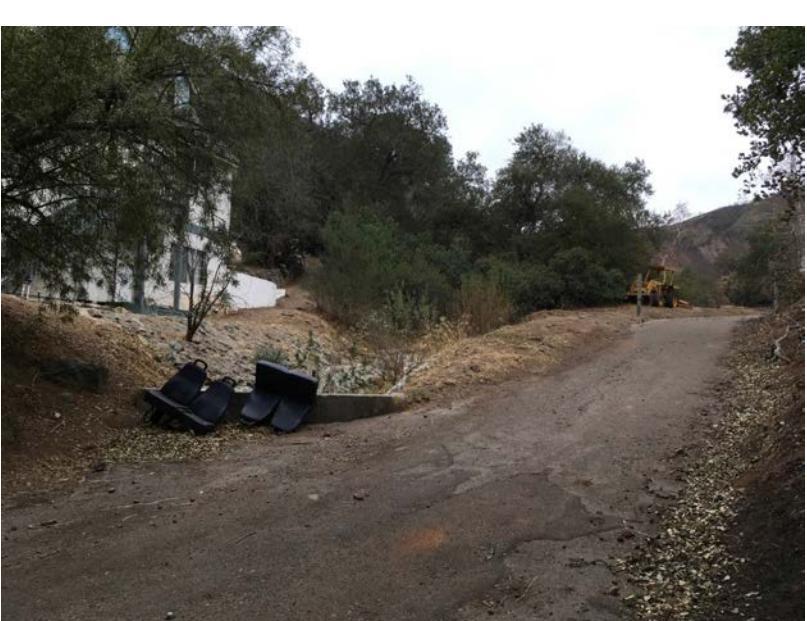
LOCATION AND PHOTO

Field Observation Roadway flooding. or Potential Hazard:

Potential Hazard to Life: moderate

Potential Hazard to Property: moderate

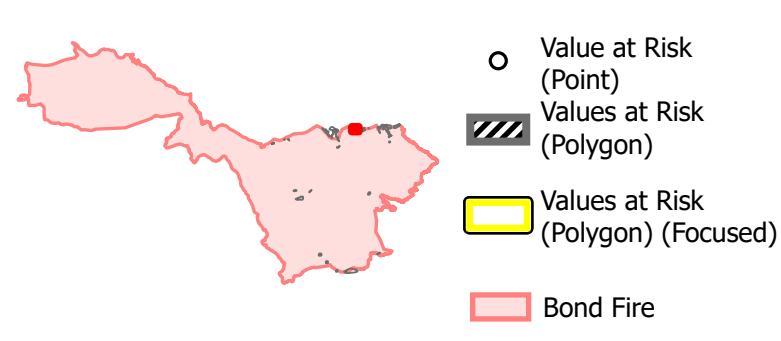
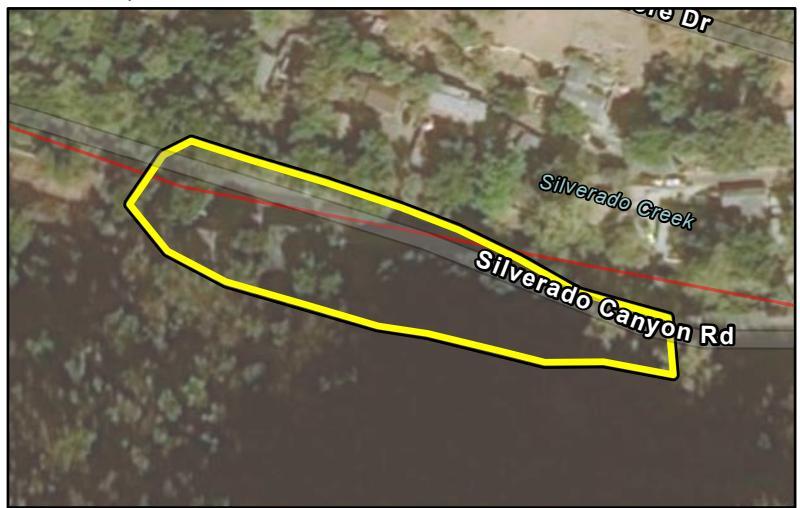
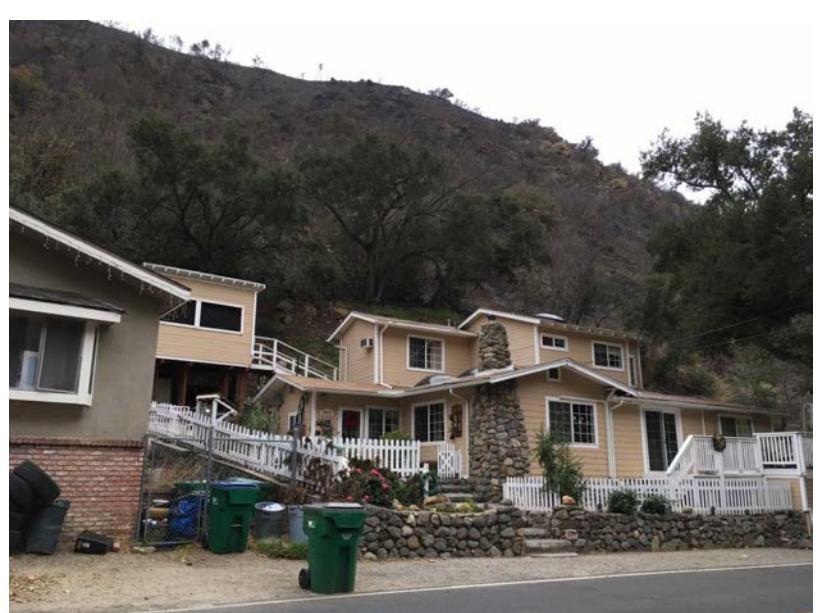
LOCATION AND PHOTO

Field Observation Rockfall, mud, debris originating from steep ascending north-facing slope to *or Potential Hazard:* rear of several homes adjacent to roadway.

Potential Hazard to Life: high

Potential Hazard to Property: high

Description: Consider Evacuation. Debris barrier construction to guard against rockfall may be worth installing in future to deal with long-range risk since these homes are situated right at the base of the steep slope.

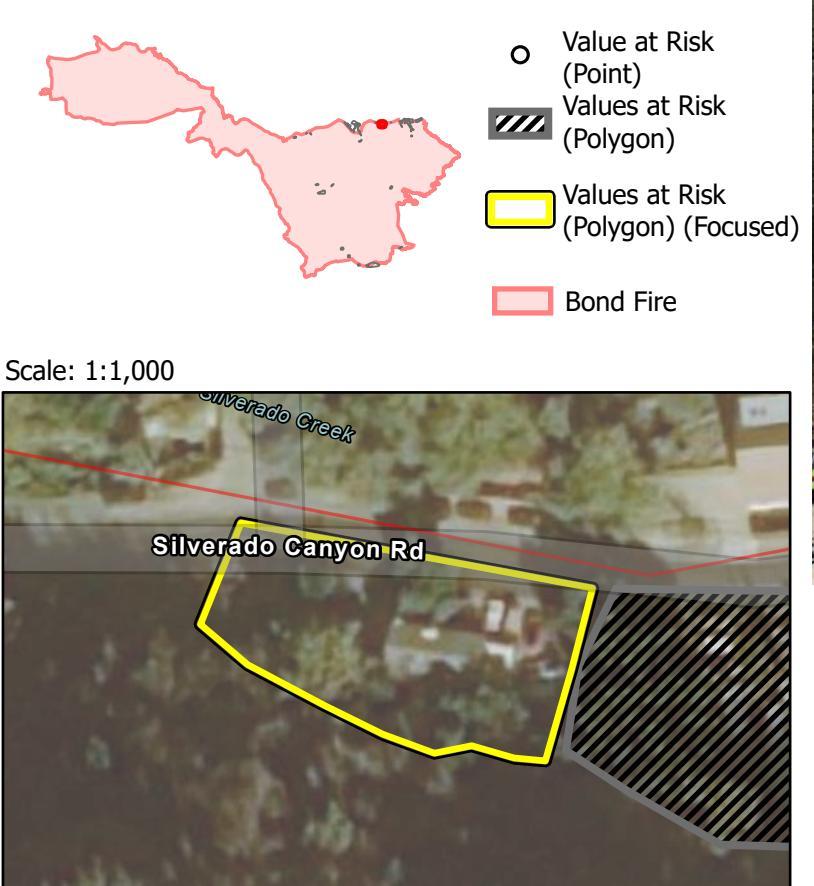
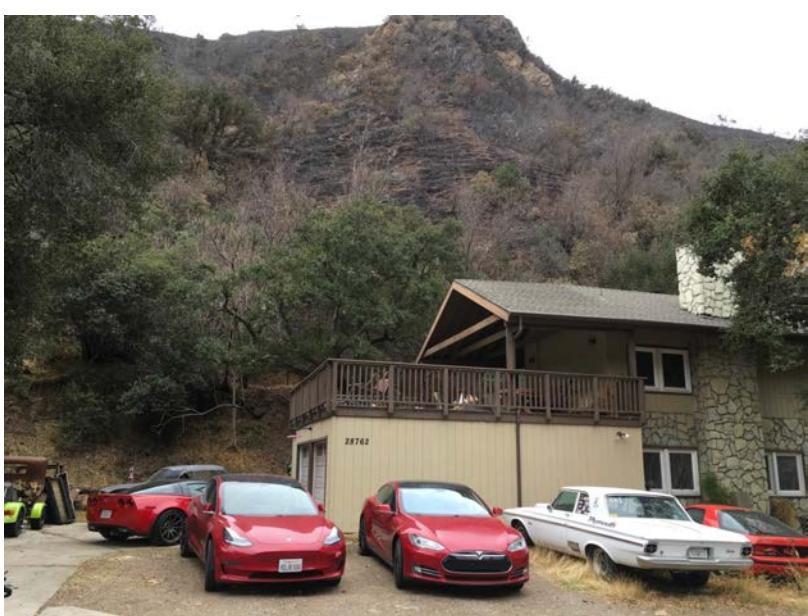
Potential Hazard to Life: high

Potential Hazard to Property: high

Description: Consider Evacuation.

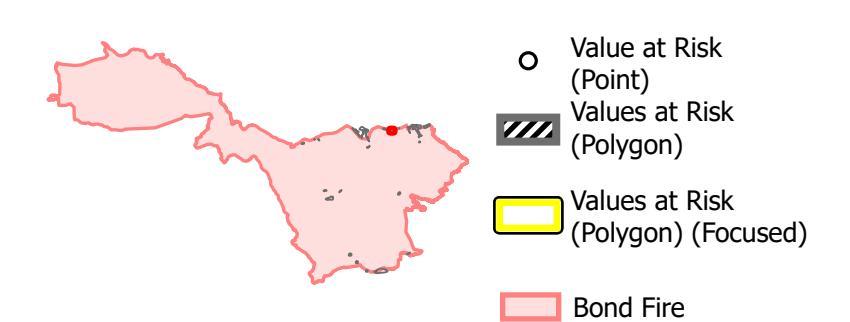
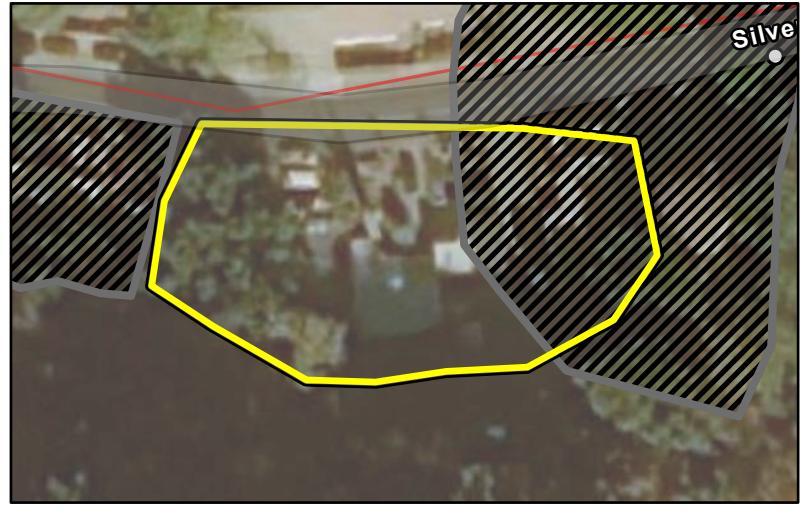
LOCATION AND PHOTO

Field Observation Rockfall. or Potential Hazard:

Potential Hazard to Life: moderate

Potential Hazard to Property: high

Description: Consider Evacuation.

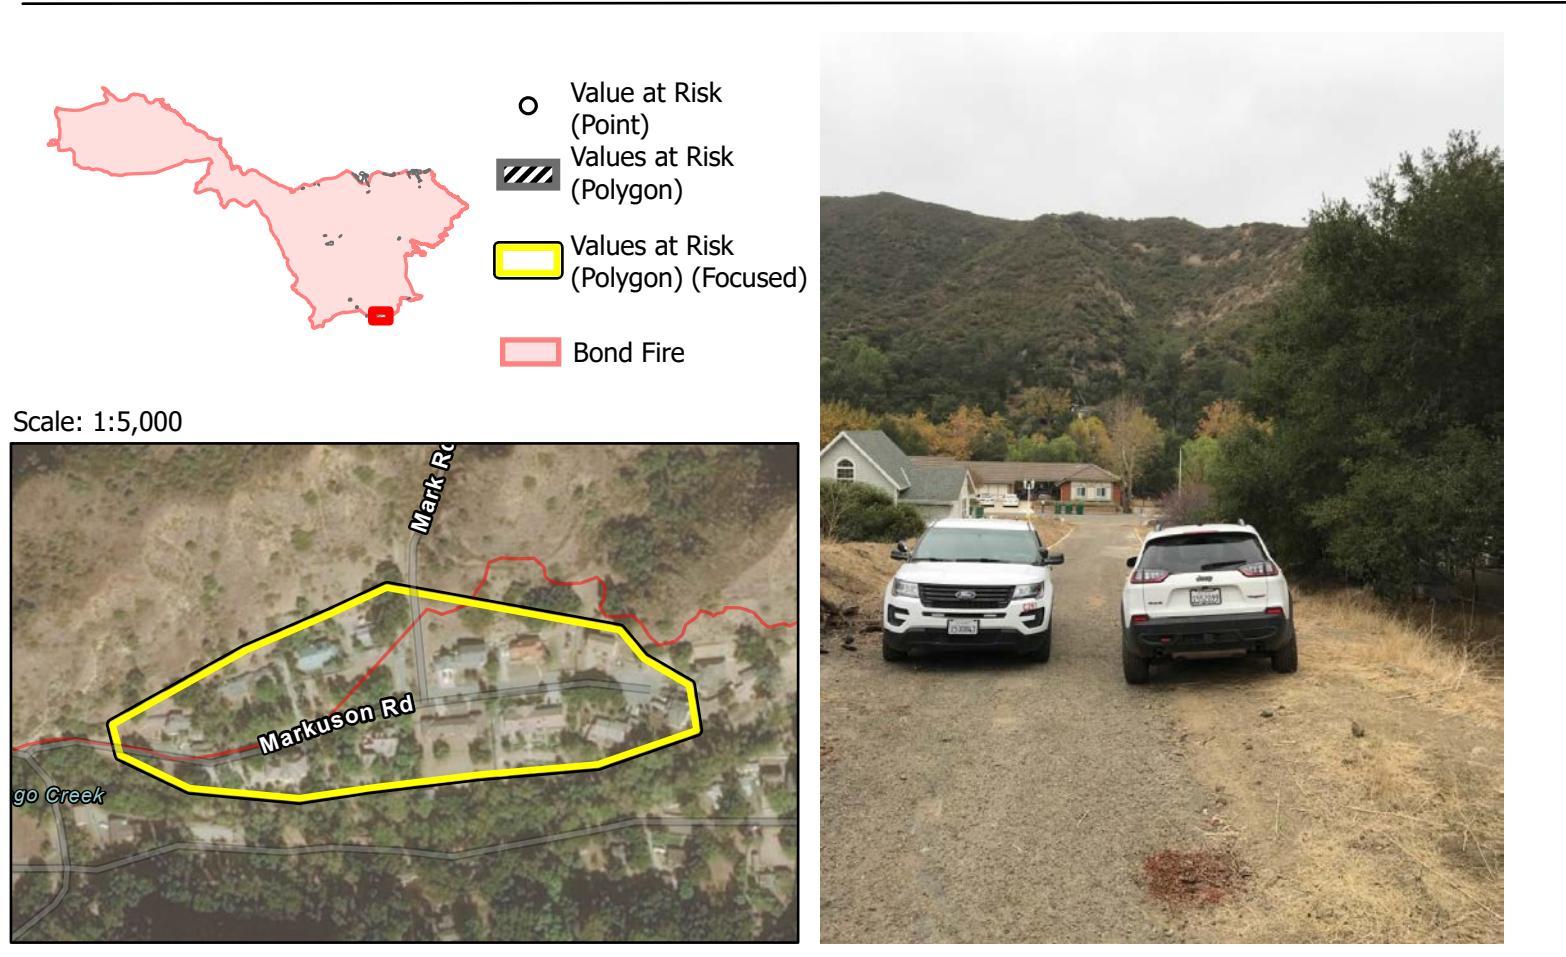
Field Observation Residences on alluvial fan at mouth of two modeled high debris flow hazard *or Potential Hazard:* catchments. Several small unmodeled catchments deliver to western end of fan complex. History of flows down Mark Road and eastern drainage impacting houses on Markuson Road.

Potential Hazard to Life: high

Potential Hazard to Property: high

Description: Potential for deflection structures at bottom of Mark Road.

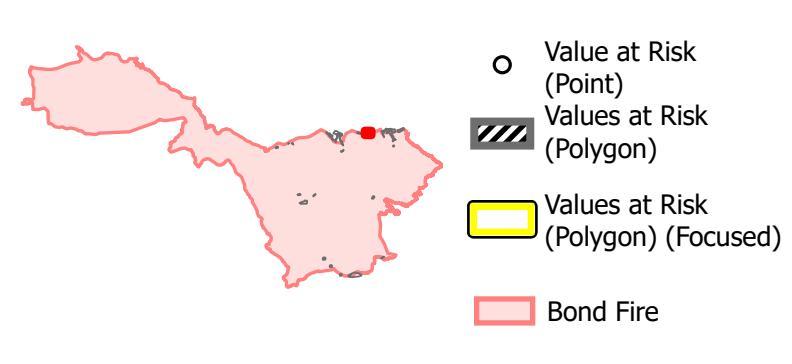
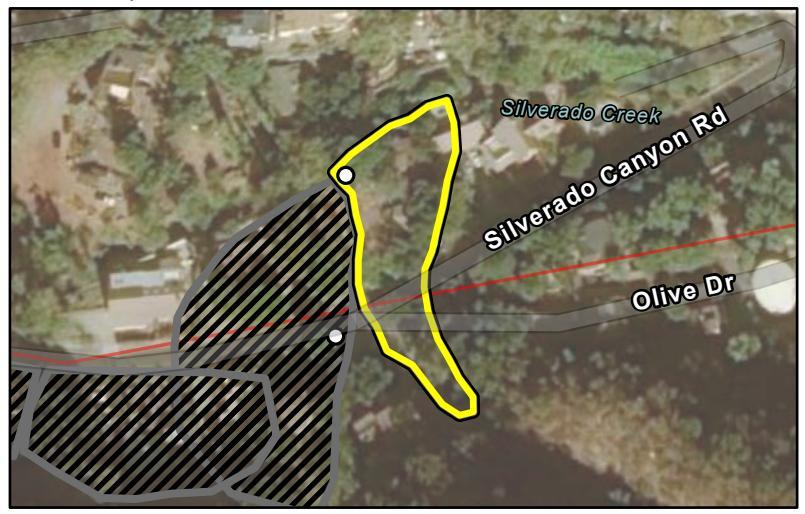
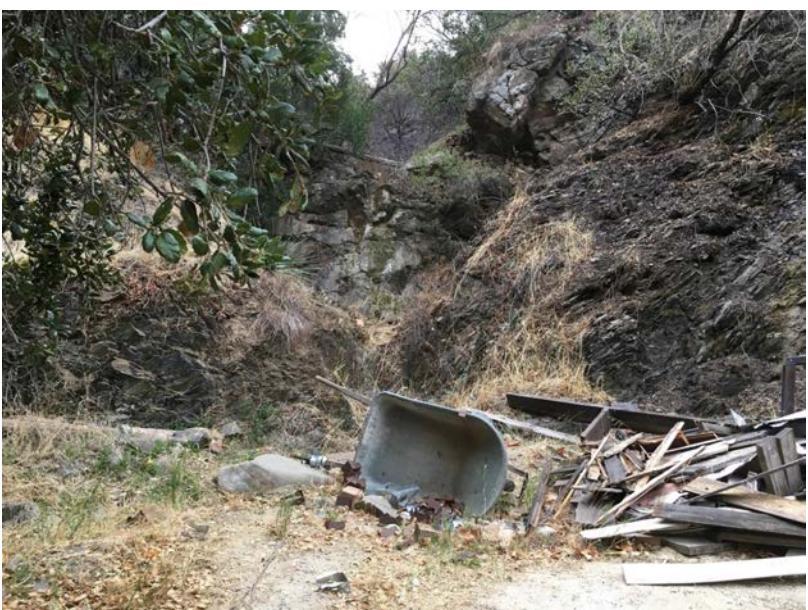
LOCATION AND PHOTO

Field Observation Mud and flood potential. Bedrock channel adjacent to driveway. According to *or Potential Hazard:* resident, water traverses the roadway and flows east.

Potential Hazard to Life: moderate

Potential Hazard to Property: moderate

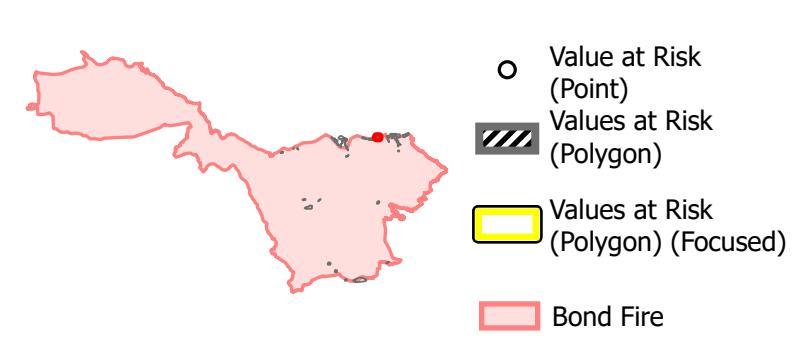
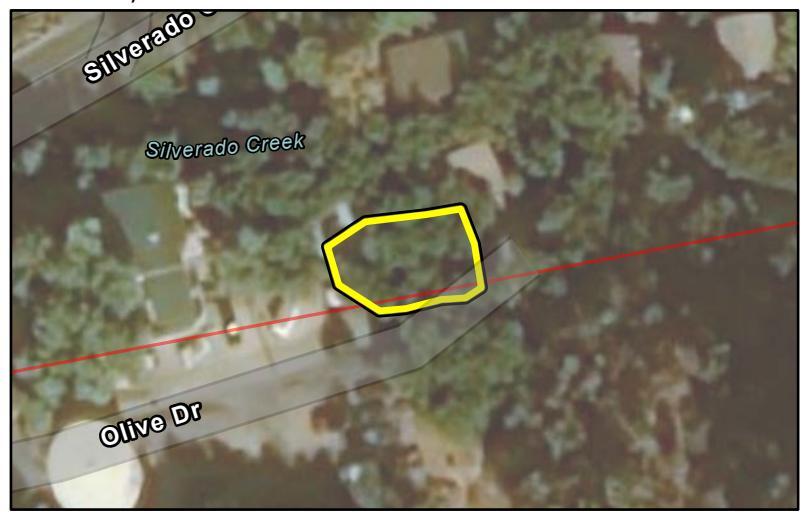
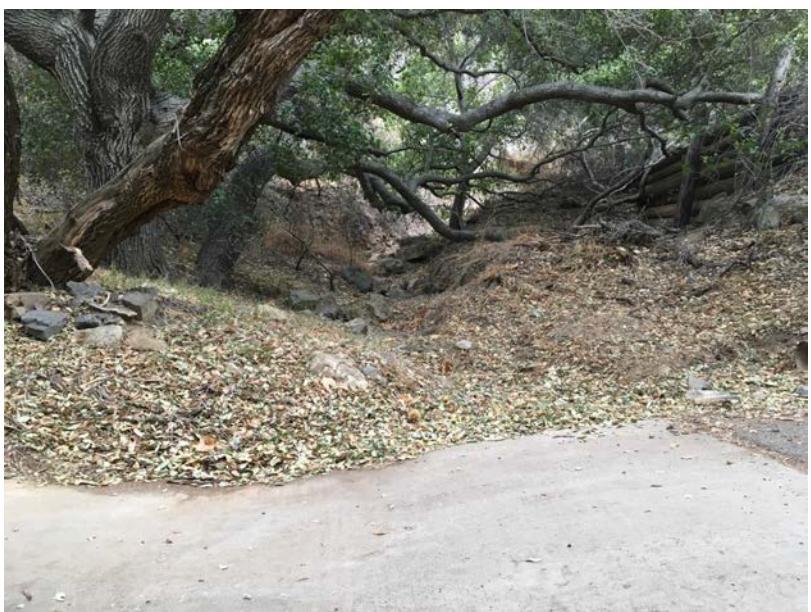
LOCATION AND PHOTO

Field Observation Moderate modeled debris flow hazard including flood damage to homes on both *or Potential Hazard:* sides of drainage adjacent to roadway. High velocity flow possible.

Potential Hazard to Life: moderate

Potential Hazard to Property: moderate

Description: Consider Evacuation. Large branches obstructing channel about 30 feet upstream of road crossing need to be cut.

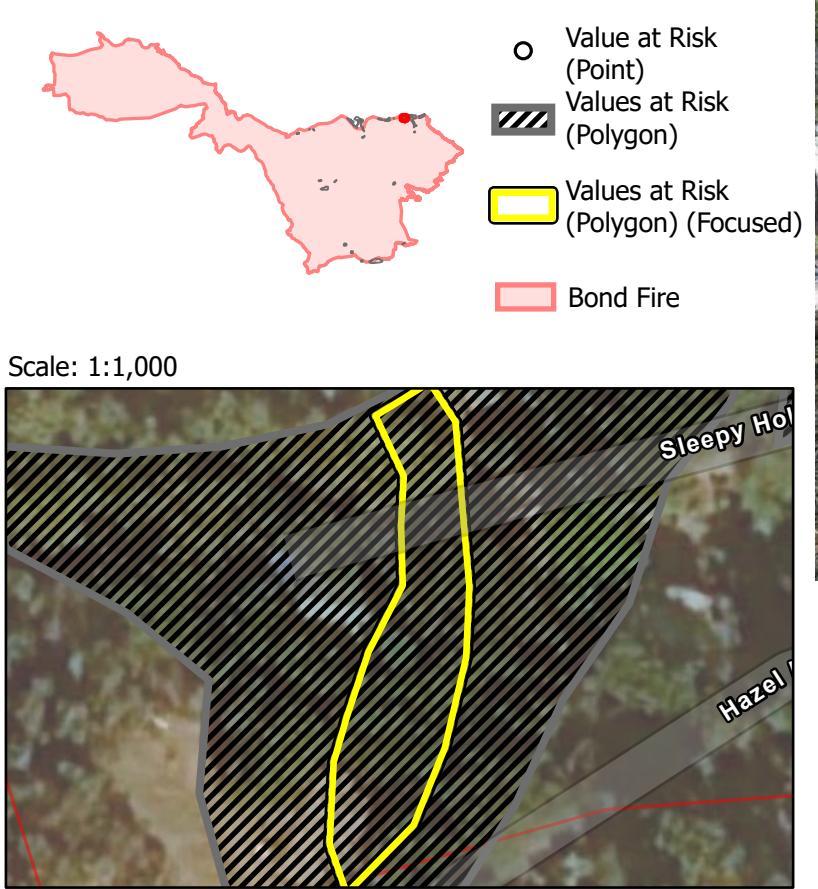
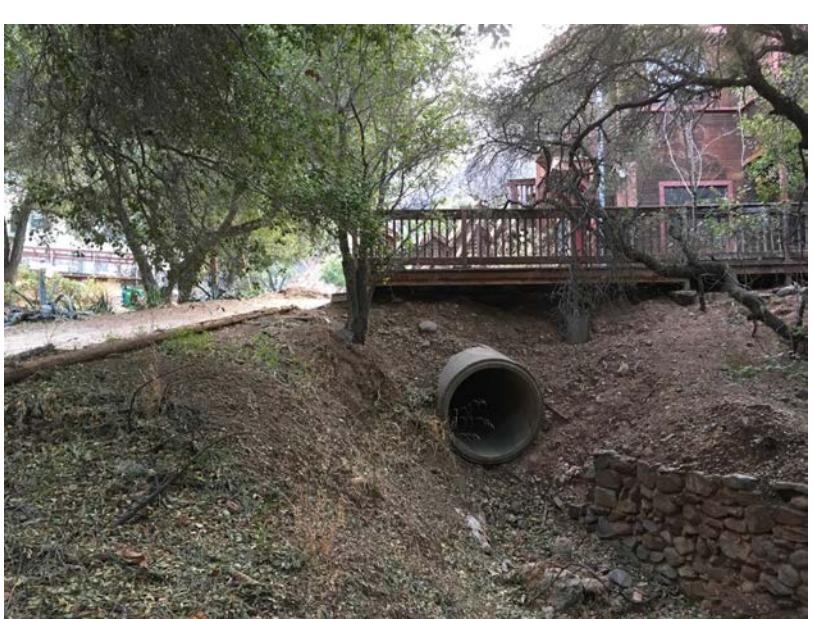
Field Observation Culverts require cleaning and maintenance to prevent impact to houses. *or Potential Hazard:*

Potential Hazard to Life: moderate

Potential Hazard to Property: moderate

Preliminary Emergency Protective Measures (4): Sandbags

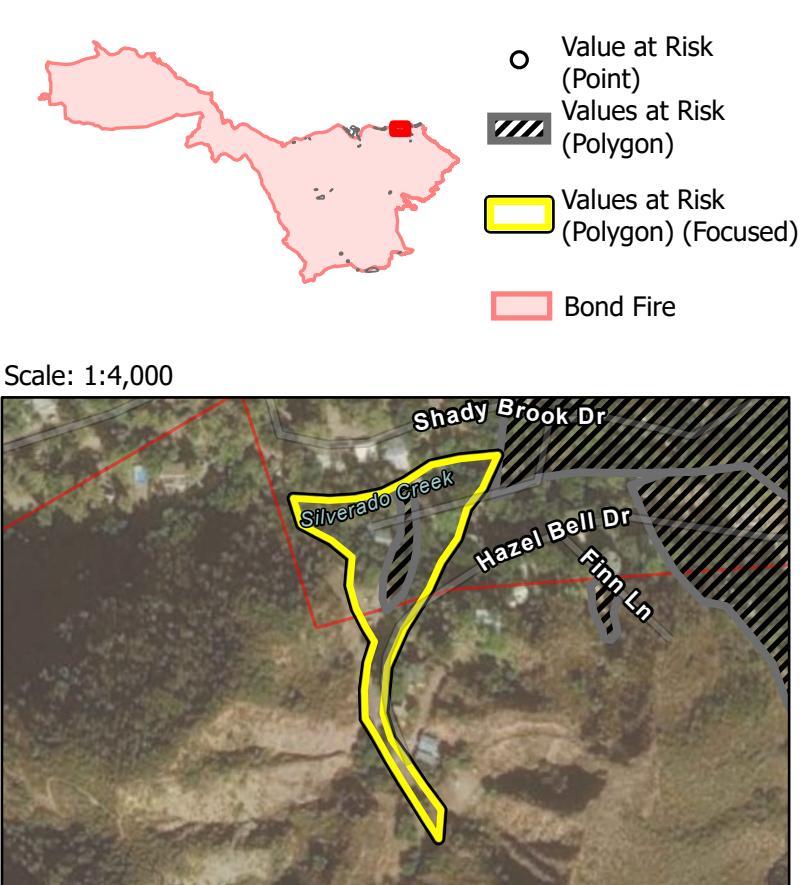
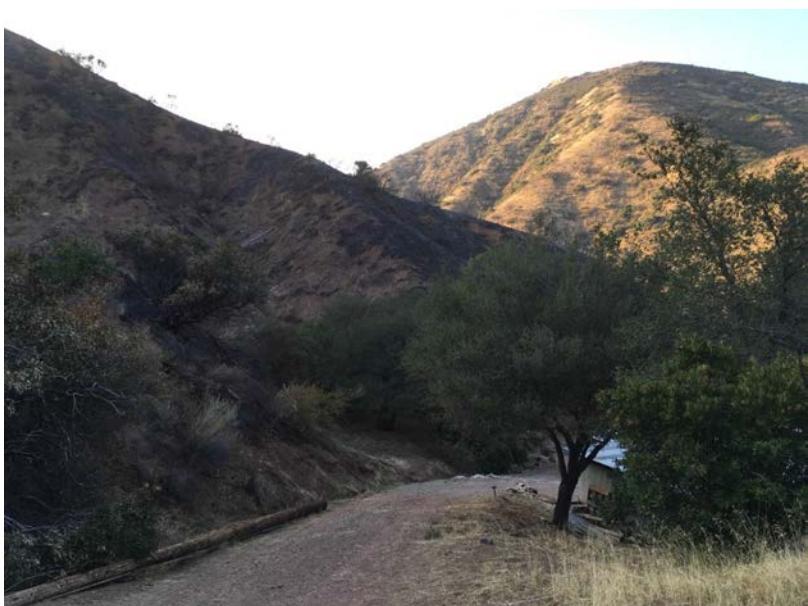
Field Observation Landslide activity visible in the hillsides east of roadway/dirt track. Area has *or Potential Hazard:* history of mud and flood with half-meter scale boulders and debris, especially following 2010 fire.

Potential Hazard to Life: moderate

Potential Hazard to Property: moderate

Preliminary Emergency Protective Measures (4): Clear and maintain culvert

Description: Consider Evacuation.
