Watershed Emergency Response Team Evaluation BOND FIRE

CA-ORC-136890

January 8, 2021

BOND FIRE – WERT ASSESMENT EXECUTIVE SUMMARY

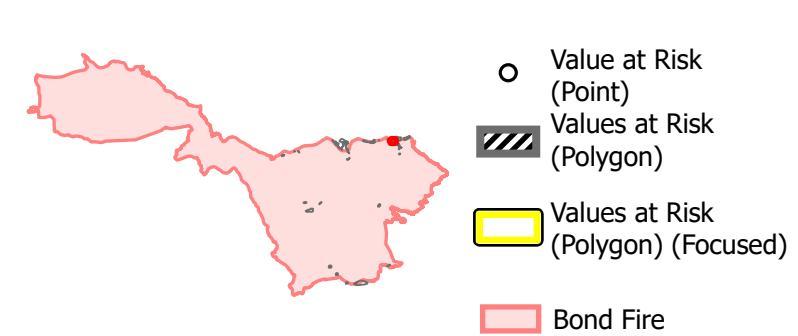
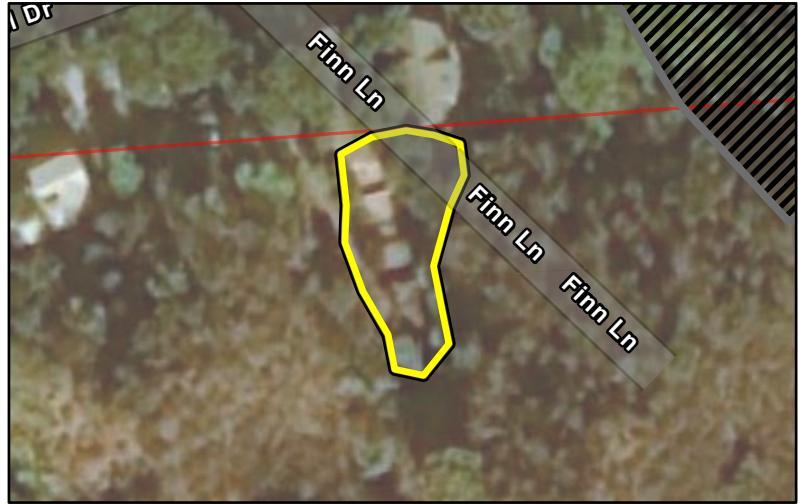
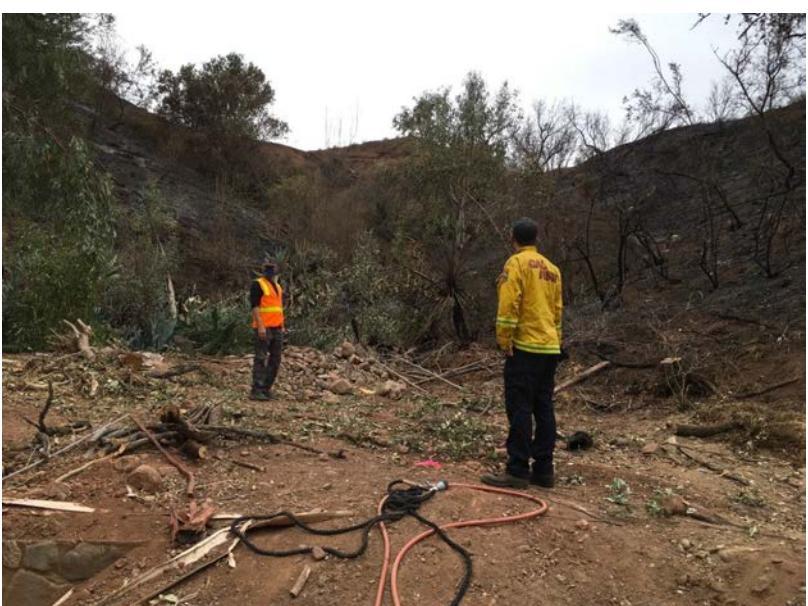
LOCATION AND PHOTO

Field Observation Upstream burned basin pours out on top of house and roadway below. New or Potential Hazard: home is being built directly in the channel/flow path.

Potential Hazard to Life: high

Potential Hazard to Property: high

Description: Consider Evacuation. This resident needs a debris barrier, retaining walls, and adequate drainage. Additional landslide hazard due to likely non-permitted grading and construction.

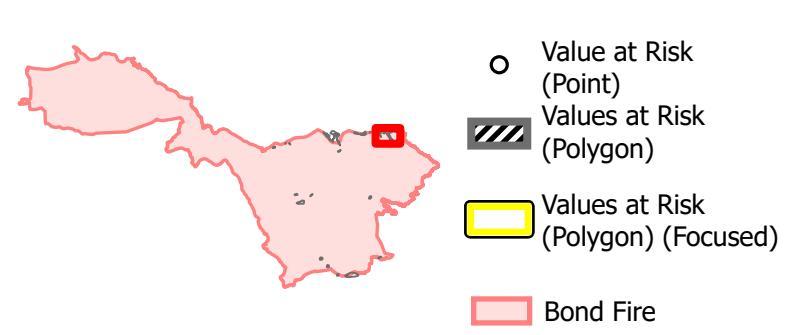
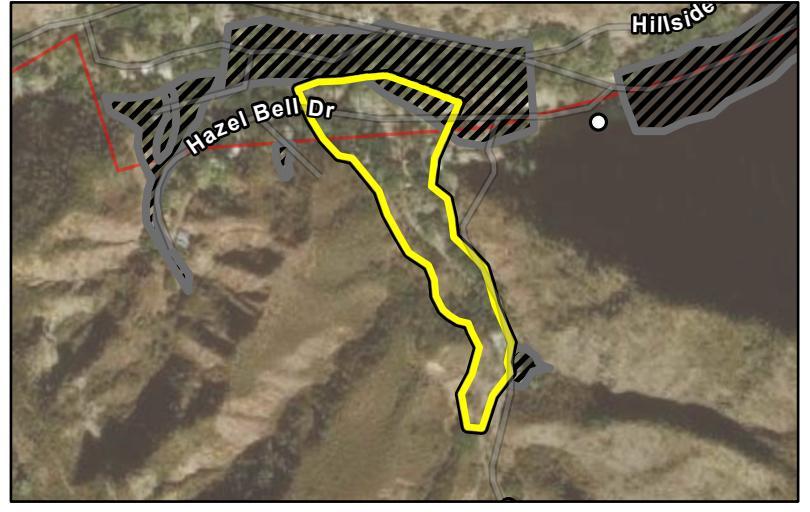
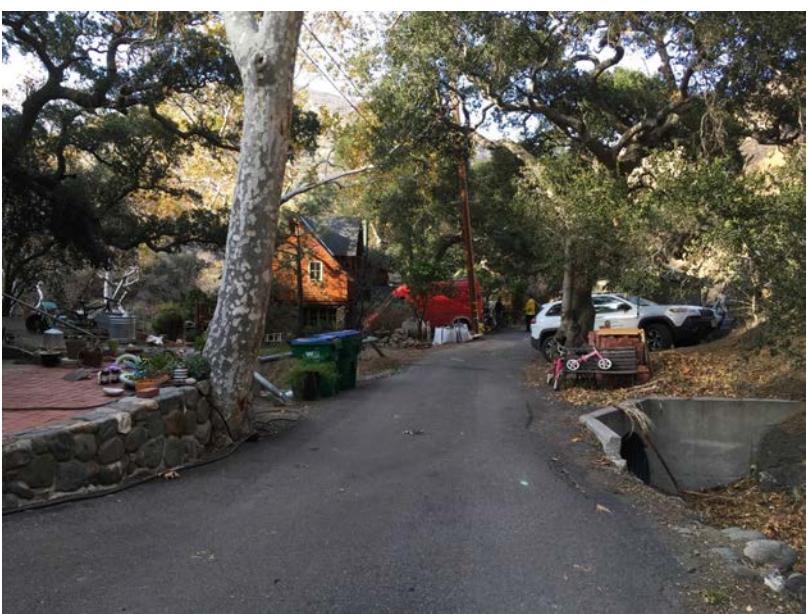
LOCATION AND PHOTO

Field Observation High debris flow and flood hazard. High danger to life. Hyperconcentated flow, *or Potential Hazard:* debris-heavy, is possible based on historic anecdotal evidence provided by local residents.

Potential Hazard to Life: high

Potential Hazard to Property: high

Description: Consider Evacuation. Wildcat Canyon Creek is a high hazard zone for life and property..

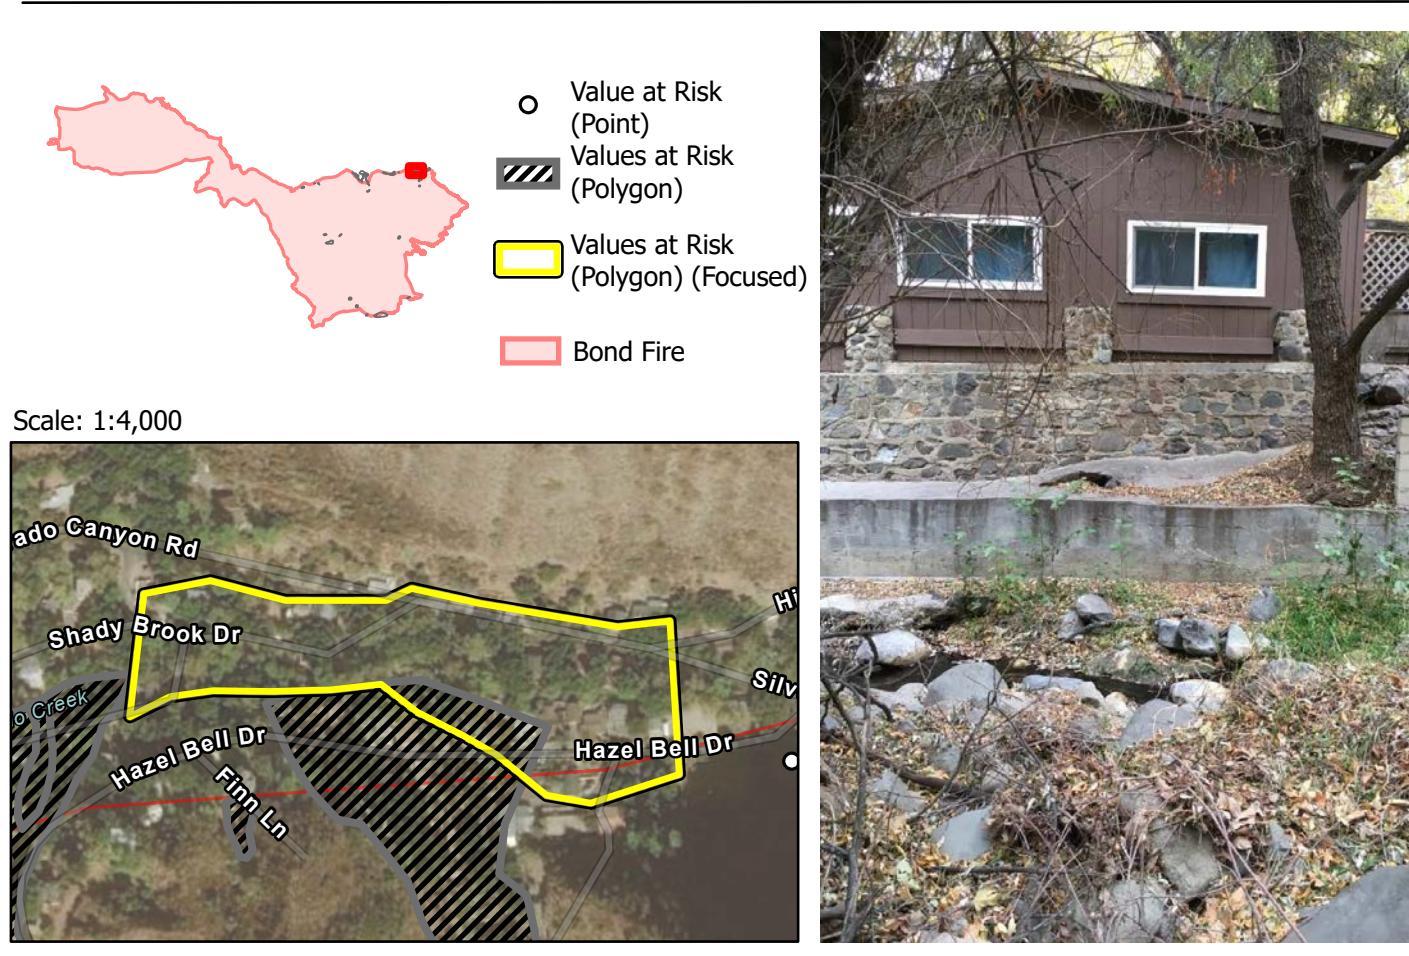
Field Observation Debris from Wildcat Canyon may reduce channel capacity in Silverado Creek at or Potential Hazard: the tributary junction or at road crossing at Sleepy Hollow Drive. Debris blockage may cause backwatering with resultant flooding to structures in the Silverado Creek floodplain

Potential Hazard to Life: moderate

Potential Hazard to Property: high

Description: Consider Evacuation. Heavy equipment may be necessary to maintain conveyance at Silverado Creek/Wildcat Canyon. Capacity of crossing at Sleepy Hollow will need to be maintained. Recommend County model flood inundation assuming blockage at both areas.

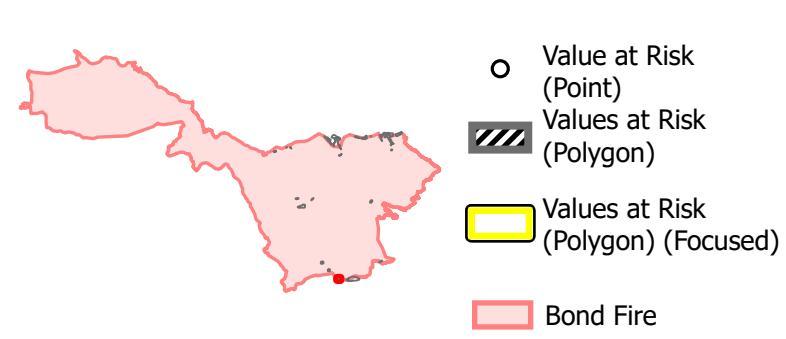
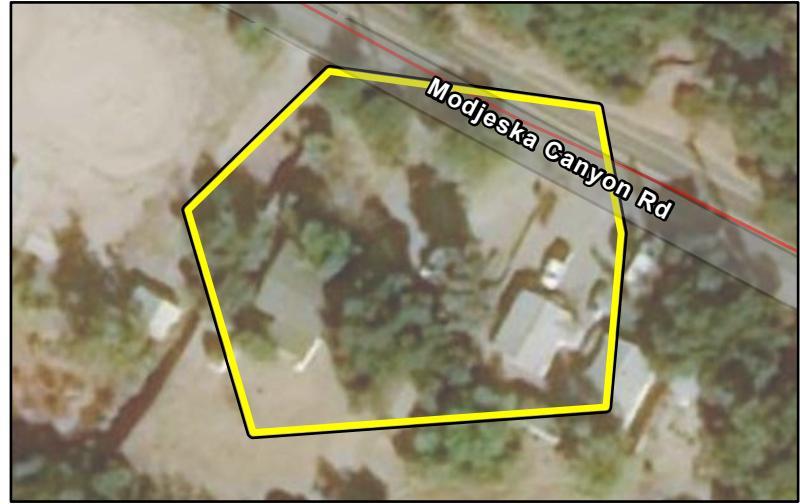
LOCATION AND PHOTO

Field Observation Houses at mouth of high debris flow potential modeled catchment. *or Potential Hazard:*

Potential Hazard to Life: high

Potential Hazard to Property: high

Description: Consider evacuation in predicted high flows.

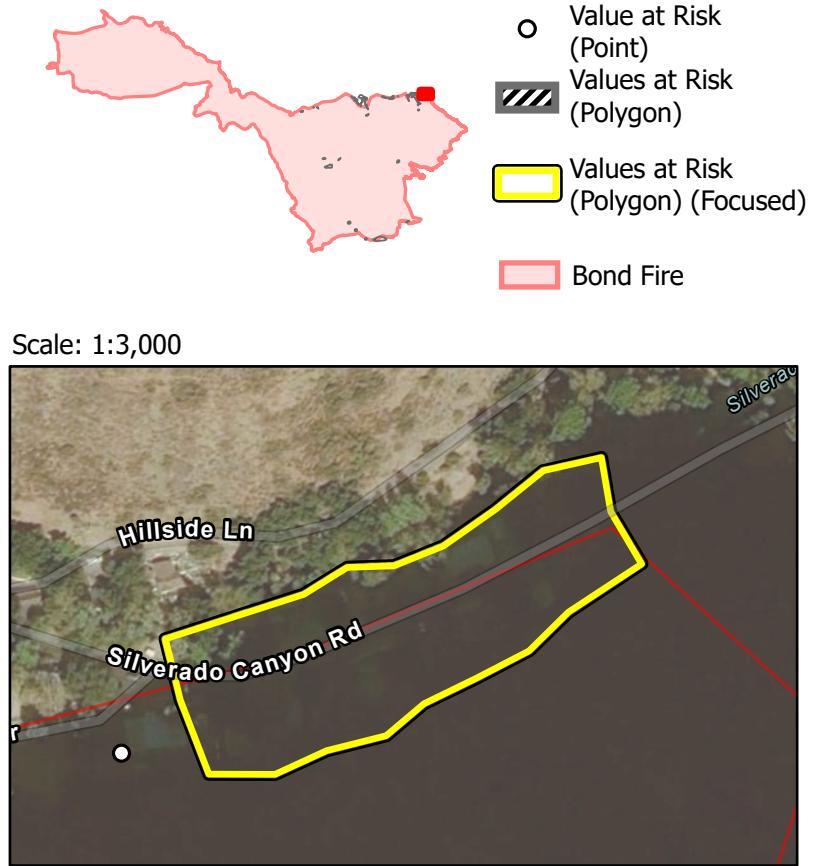
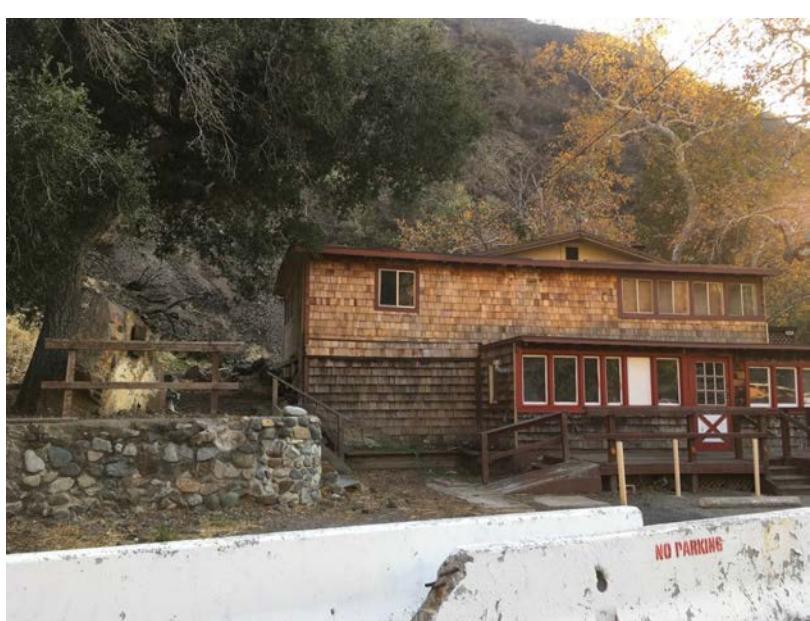
Field Observation Hillside oversteepened and site of previous fatality at Old Shadybrook Country or Potential Hazard: Store. Ascending north-facing slope requires additional analysis of hazard.

Potential Hazard to Life: high

Potential Hazard to Property: high

Description: Consider Evacuation. There is a well-documented hazard in this area. A 16-year old girl died at 29442 Silverado Canyon (Old Shadybrook Country Store) in 2005 due to rockfall.

Preliminary Emergency Protective Measures (4): Deflection structure

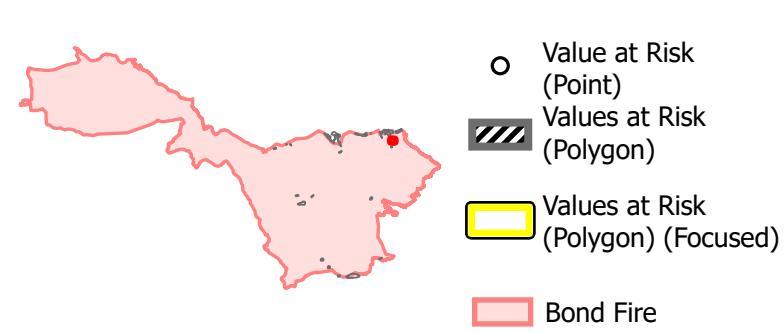
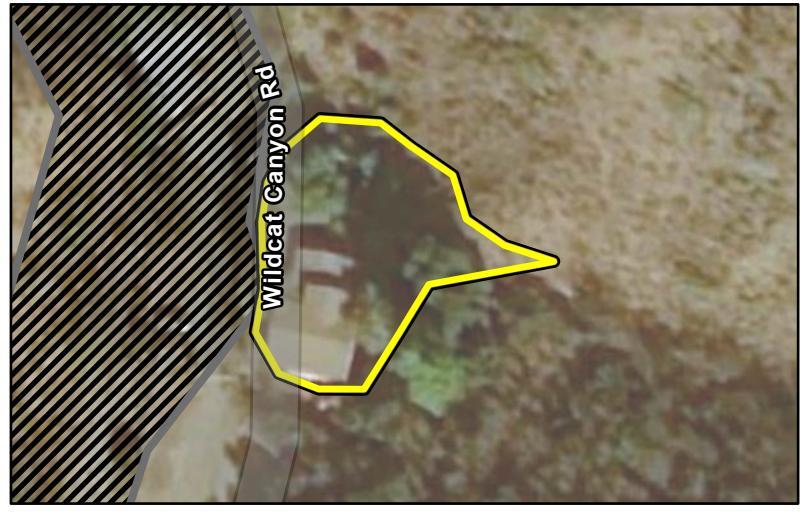
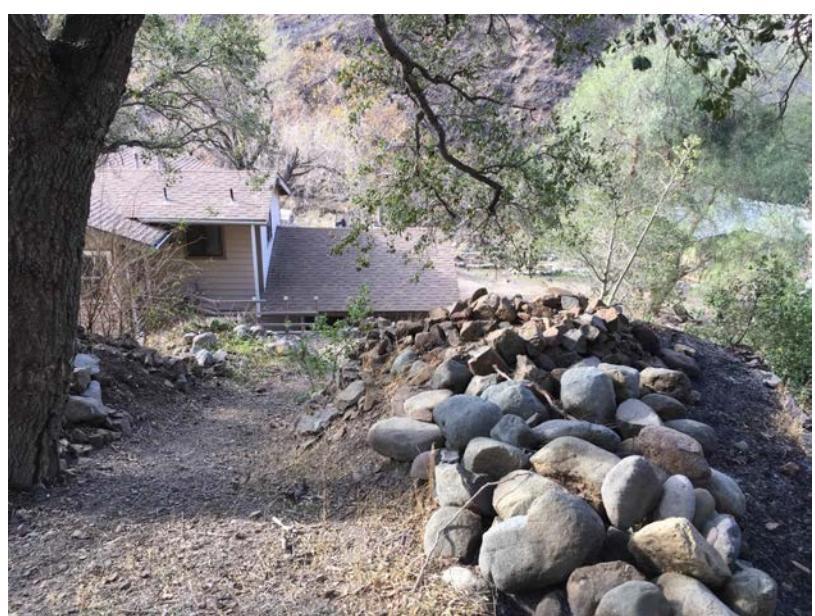
LOCATION AND PHOTO

Field Observation Oversteepened channel behind home extends upwards into a chute channeling *or Potential Hazard:* rockfall. Existing debris flow deposits uphill of home. Resident described previous flooding on north and south sides of home.

Potential Hazard to Life: high

Potential Hazard to Property: high

Description: Consider Evacuation. This is a high risk location.

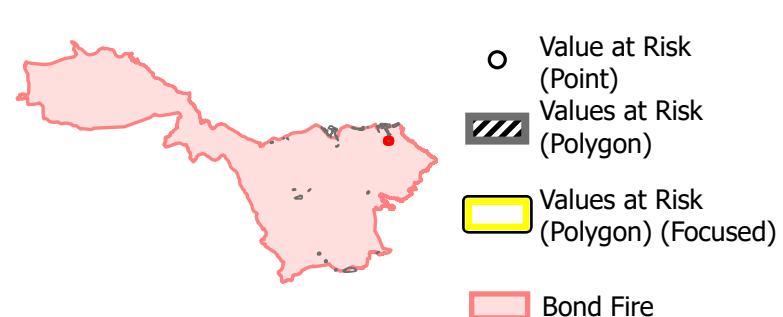
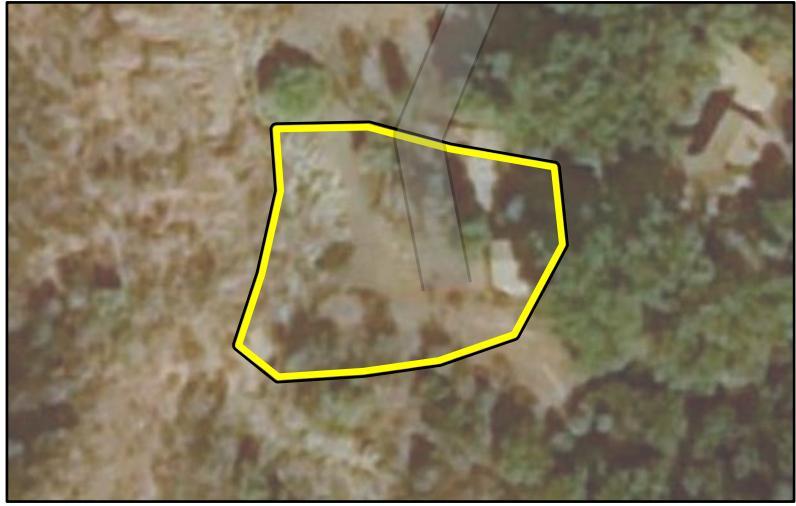
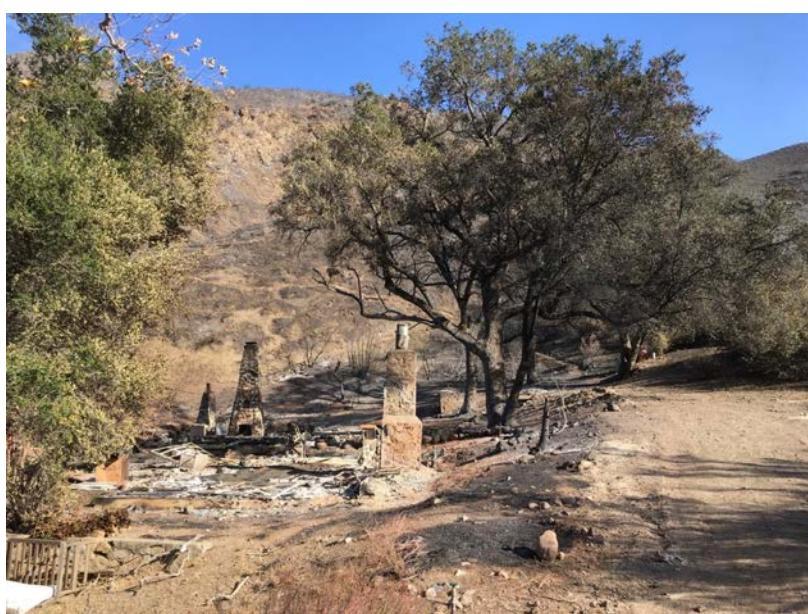
LOCATION AND PHOTO

Field Observation Debris flow hazard, stream flooding and hillslope failure hazard. *or Potential Hazard:*

Potential Hazard to Life: high

Potential Hazard to Property: high

Description: Consider Evacuation. This is a high hazard area.

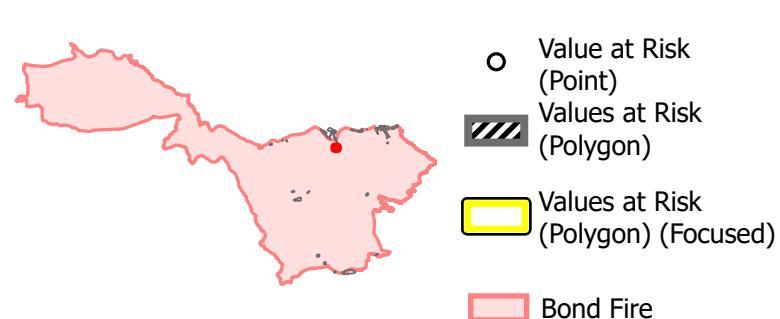
LOCATION AND PHOTO

Field Observation Outbuildings and property are located at the base of a small but steep *or Potential Hazard:* catchment. There is a risk for rockfall at this location. Additional ingress/egress problems if White Canyon creek inundates drainage structures at Anderson Road.

Potential Hazard to Life: moderate

Potential Hazard to Property: moderate

Description: Consider Evacuating if occupied and forecasted storms predict flood or debris flows.

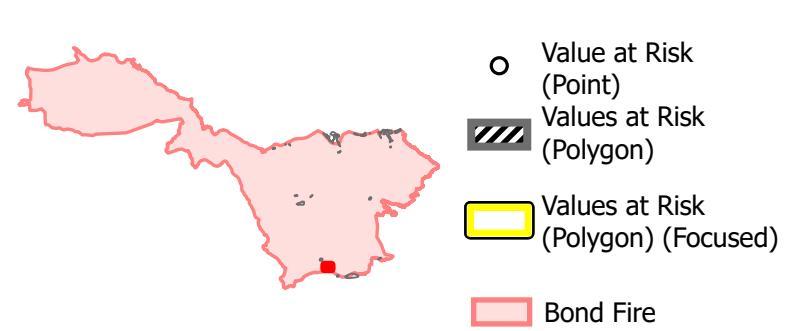
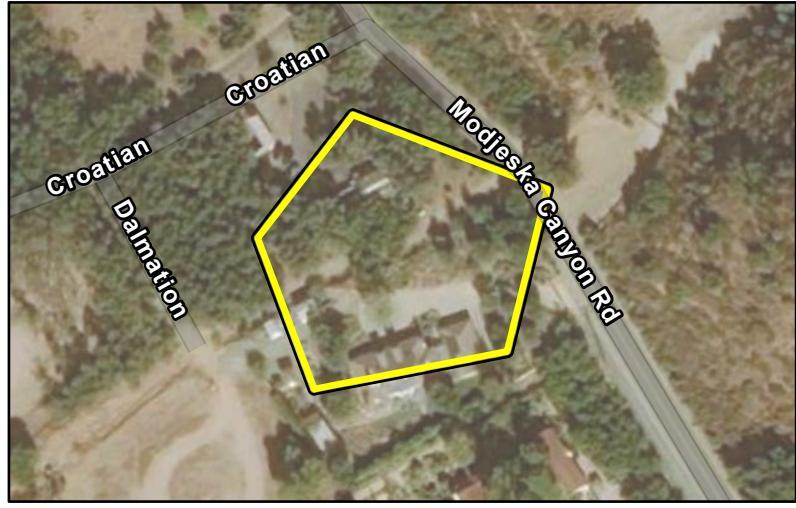
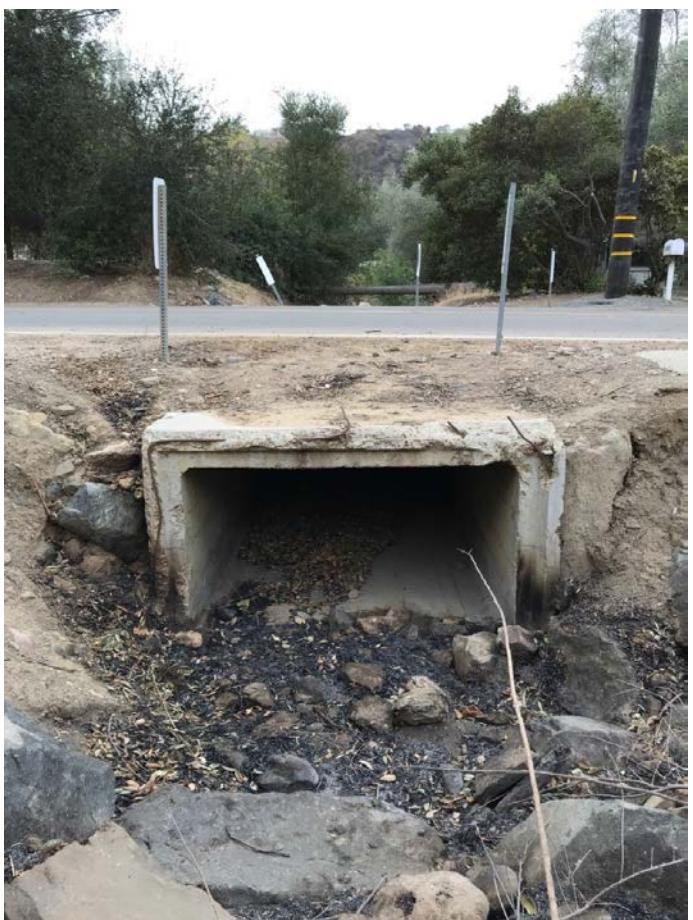
Field Observation Houses in potential flow path of high modeled debris flow catchment. *or Potential Hazard:*

Potential Hazard to Life: low

Potential Hazard to Property: moderate
